**Atlantic Whitefish Recovery Project**  
**Water Quality & River Surveys**  
**Summary Report**  
**April 2009 to March 2010**

## WATER QUALITY MONITORING 2010

## RIVER SURVEYS 2009

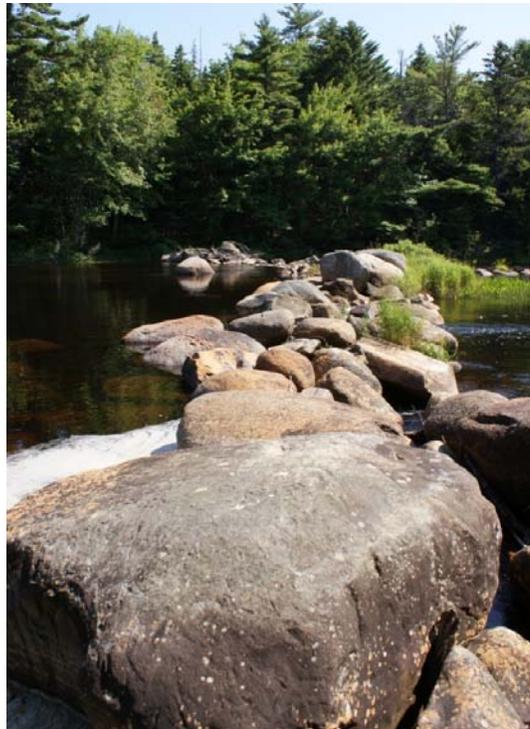
In several locations there are rock wall structures remaining from previous damming operations in the past on the Petite Rivière. The Crousetown dam site is the most obvious site. Above and below the dam there are two places where a man-made rock wall exists. The first (below the dam) is a small rock wall that is intended to direct water around an island and help to increase the water depth in this area. Although, on one hand, it may be helping a little bit with the water depth on the other end of the island, the fish can still attempt to make their way up stream and get blocked by the rock wall and have to move back downstream to locate the correct passage. In addition, at this site, as a result of the numerous diversions around islands and the rock wall, there has been erosion occurring on the right side of the bank as well as sediment deposition causing the area to become very wide and shallow. The site upstream from the fire pond consists of a large rock wall stretching across the width of the entire river with a fish passage of less than 1 metre on the left bank (see below). The rocks in this wall are very large and there is a large still water behind it. Restoration needs to be done here to increase water flow through the whole width of the river and to increase the area for fish passage across the rock wall.

Full length rock wall above Fire Pond bridge.

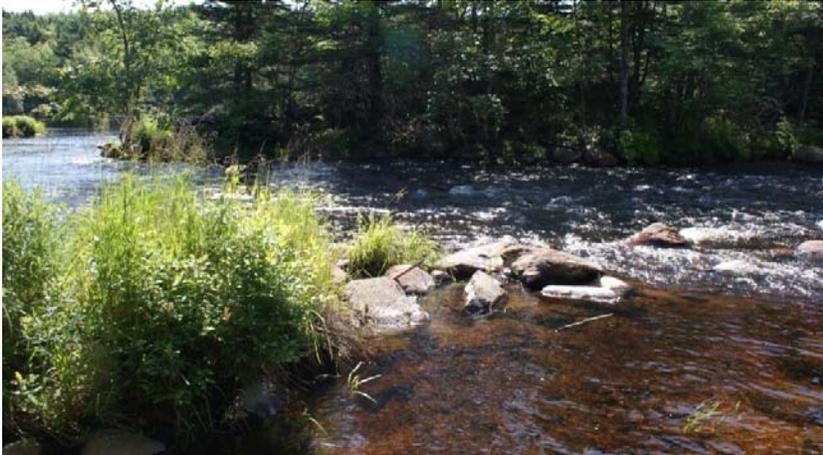
Another location flagged for restoration this summer is an area at the outlet of the fire pond in Petite Rivière (see below). Where the bank has eroded between the pond and the river at this site, there is a steady stream of water flowing out of the pond and merging with the river; however, the angle of the fire pond outflow is causing the adjacent bank to become eroded at this point. As a result this area is very flat and shallow with a build up of sediment. Building up the opposing bank and reinforcing it would decrease the rate of erosion and help to divert water back into the channel to increase its depth.

Fire Pond outlet.
