2012 Field Report

LaHave River Watershed Project

Bluenose Coastal Action Foundation

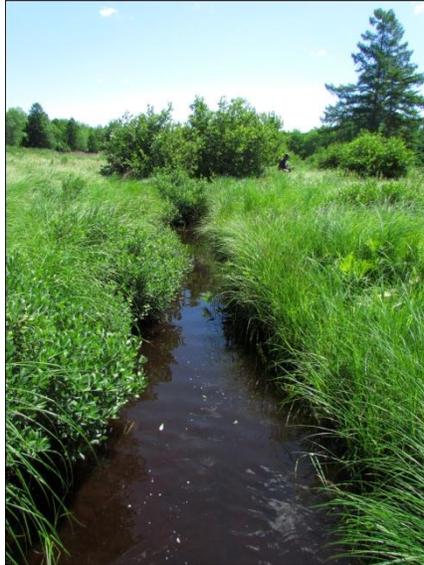
Figure 1. A photo of Silver Mill Brook, a tributary of the LaHave River.

Silver Mill Brook is a tributary of the LaHave River and runs through local property owner Kevin Veinotte's farm (Figure 1). Historically, this brook was straightened to maximize farm land and was accessible to cattle; however, nine years ago the brook became protected by the installation of an electric fence and cattle access was significantly limited. The goal of this summer's restoration project was to physically improve the in-stream structure of the brook, to slowly improve fish habitat and to help re-establish a natural meander pattern. Digger logs create pools and gravel beds immediately downstream of the log, which serve as cover, resting areas, and spawning areas for fish travelling upstream. Digger logs also clean and oxygenate the water creating quality habitat for aquatic invertebrates (Figure 2).

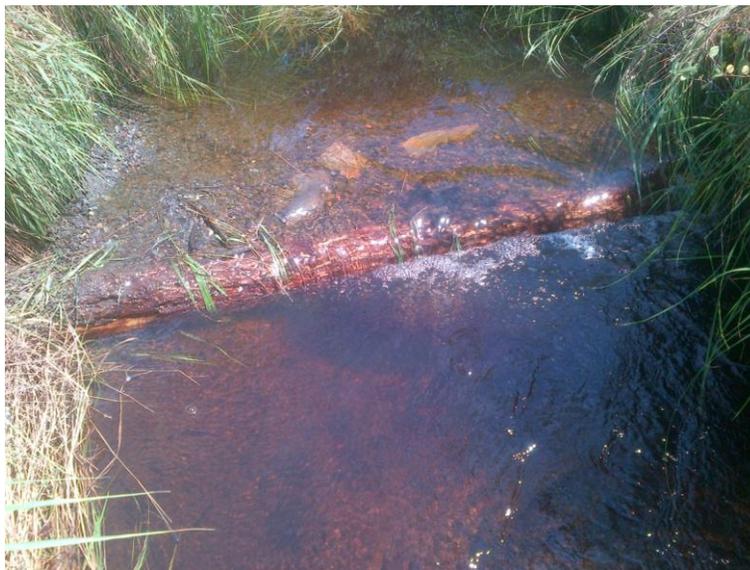
Figure 2. Picture of a digger log installed in Silver Mill Brook.

Logs are cut to length to fit a 60 degree angle parallel to the bank of the brook. This angle helps direct the water into the bank to create the meander. The logs are also placed at a 3-5 degree angle, with the lower end upstream. The holes are drilled into the log for the 5/8" length of rebar that is used to secure the log into the substrate of the brook. A channel in the substrate is cleared for the log; pickaxes and

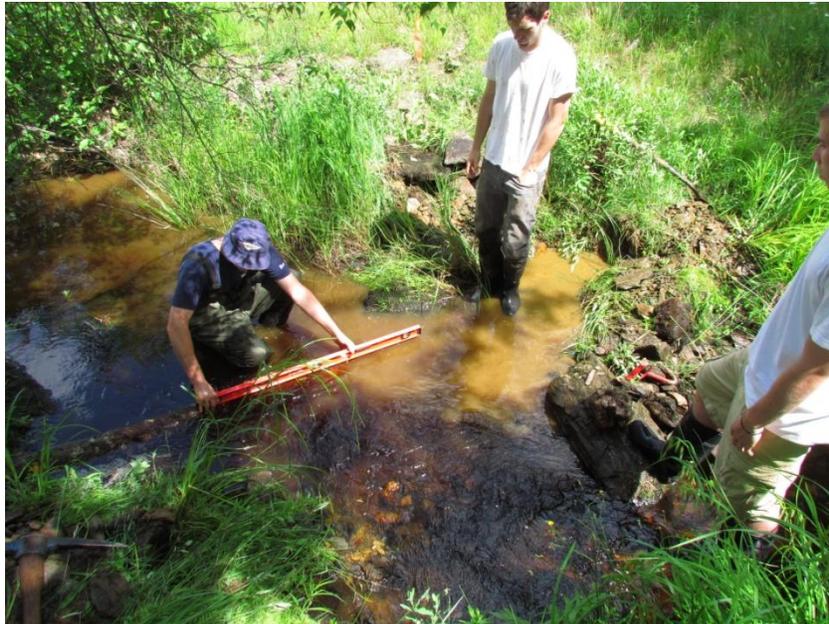
Figure 3. Measuring the gradient of a digger log during installation.

shovels are normally used. Ideally, the channel is dug so the water cascades over the high portion of the log. Once installed, a pool is dug on the downstream side of the log. The rock and gravel removed from downstream can be used on the upstream side to create a ramp and a riffle. The ramp is important, with it the water will flow up to the peak of the log and then cascade down over it where it will begin to erode away parts of the streambed and create a larger pool (Figure 2). Weeks after installation, previously absent schools of fish were observed in the pools below the digger logs. During the summer of 2012, 24 digger logs were installed in Silver Mill Brook (Figure 3).

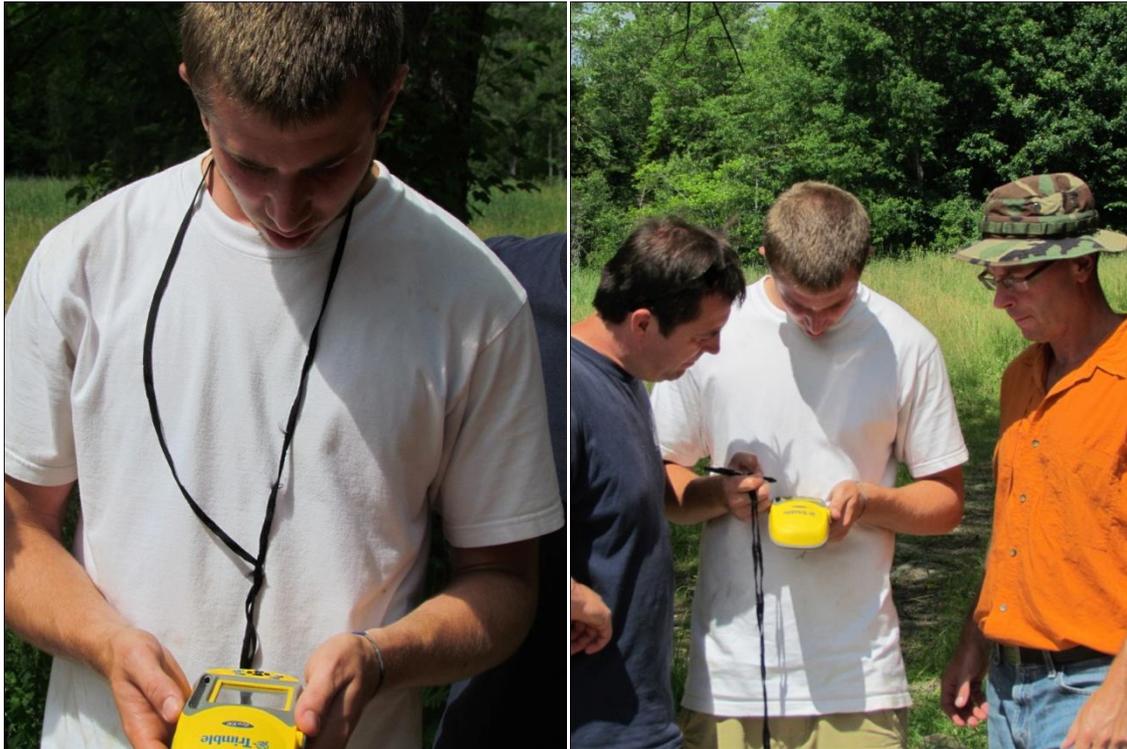
Figures 4 & 5. LRWP staff learning how to use the Trimble unit for conducting Riparian Health Assessments.

Using a portable Trimble Unit and Arc Pad software, LRWP staff mapped dozens of kilometres of riparian area along branches of the LaHave River and its tributaries (see Appendix 1). The riparian area is the land around a river or stream that is characterized by water-loving plants. Every time the riparian area appears to change, a series of 13 questions related to the riparian area are answered, determining an associated health with the traced region. After the questions are completed, the unit records the data along the line it just traced. A score above 80 is excellent health, from 60-80 is moderate, and below 60 is poor. By completing these assessments it can be determined which riparian areas are unhealthy and where future restoration efforts should be focused.
