# LaHave River Watershed Project

## 2014 Field Report

Prepared by: S. Fredericks

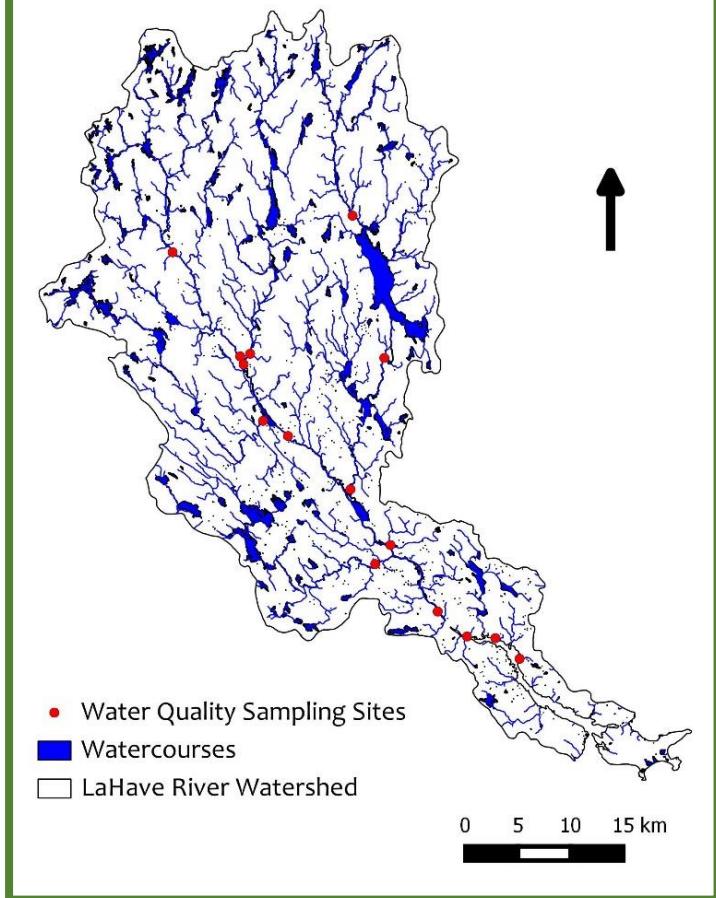
**Figure 2.0 – Water Quality Sampling Sites in the LaHave River Watershed**

identified in order to capture the water conditions throughout the entire watershed. Monitoring occurs from the headwaters to the estuary and includes all of the sub-watersheds, the main stem of the river, and downstream of the three waste water treatment plants in the watershed (see Figure 2.0). These sites are monitored on a monthly basis for physical, chemical, and biological water quality parameters.

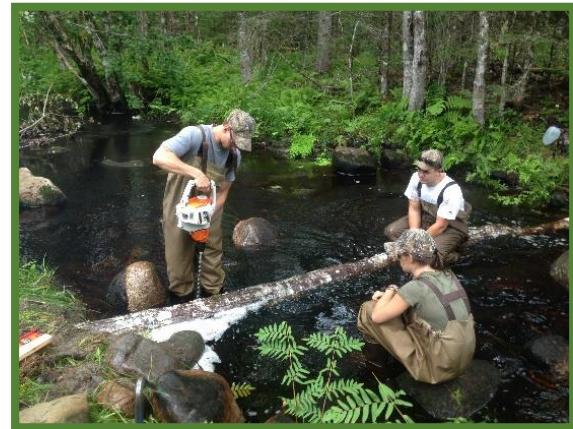
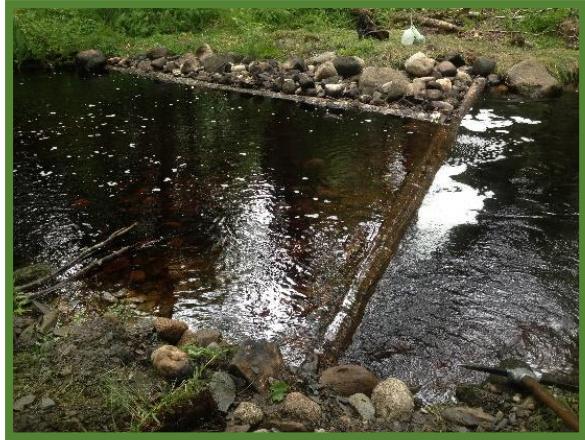
### Sheridan Brook Fish Habitat Restoration Project

Sheridan Brook is a 5 km tributary within the West River Sub-watershed. Habitat assessments performed in 2013 identified a straight, shallow, over-widened stream section in need of restoration. Shallow water with a lack of cold-water pools provides poor quality habitat for fish and can suffer from high water

temperatures and low dissolved oxygen. Five digger logs and 2 deflectors were installed along 240 m of this stream near its confluence with the West River LaHave, restoring 1,440 m<sup>2</sup> of fish habitat. Digger logs help to create deep pools through the scouring action of water as it flows over the logs, and over time they assist the stream in re-establishing a natural meander pattern. Deflectors also help to direct stream flow into a natural meander pattern, as well as encouraging sediment deposition along the over-widened stream banks.

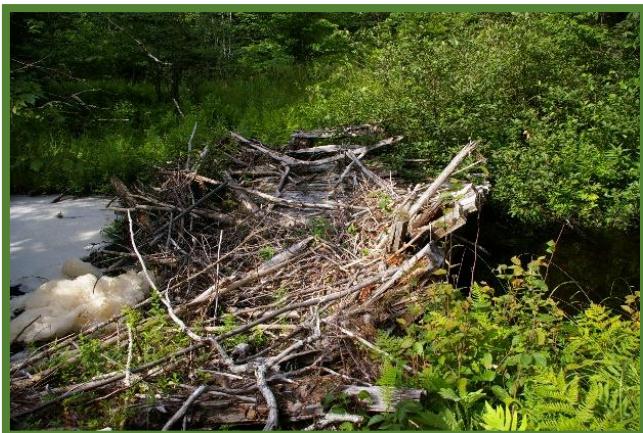
### Mackays Brook Aquatic Connectivity Restoration Project

Mackays Brook is a 4.5 km tributary within the North Branch Sub-watershed. During habitat assessments, an old timber bridge which had fallen into the stream was determined to be posing a significant barrier to fish migration. The fallen bridge had been collecting woody debris for several years and at the time of assessment only a small 1 ft<sup>2</sup> opening remained for fish to swim around the structure to access upstream habitat. The bridge was removed and the damaged

stream banks were restored by planting 23 native riparian shrubs. Removal of this structure has restored fish passage to the 4 km of Mackays Brook upstream of the bridge location.

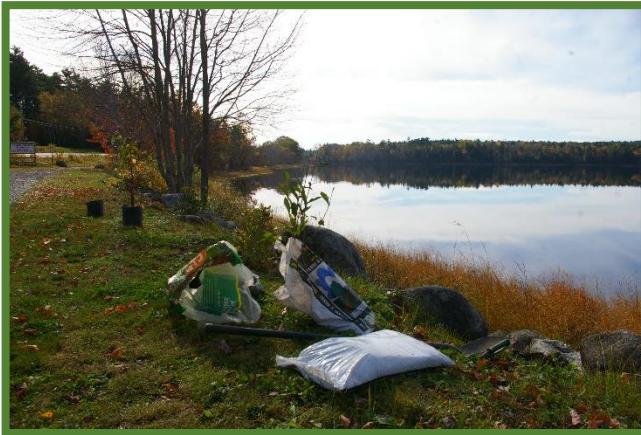
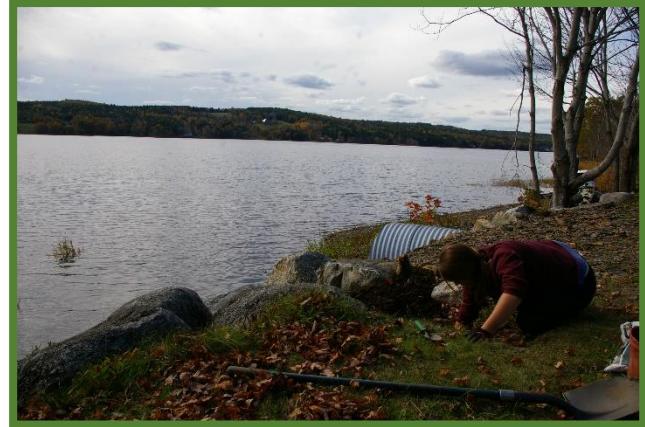
### Wentzells Lake Riparian Restoration Project

The entire North Branch Sub-watershed drains into Wentzells Lake where it joins with the main stem of the LaHave River. The eastern edge of the lake is bordered by the LaHave River Trail and the Trunk 10 Hwy. Several sections of the eastern shoreline are suffering from riparian degradation, which is resulting in run-off and erosion problems. Much of this degradation stems from illegal clearing of vegetation on crown land and from

landowners removing vegetation to maintain their lake views. These harmful activities needed to be addressed before any restorative efforts took place to ensure that the project would achieve its goals. The LRWP hosted an outreach event, led by Reg Newell from the Department of Natural Resources, to engage the local landowners in the project and inform them of the many benefits that a healthy riparian habitat provides. Following this event, a 100 m section of shoreline was planted with 24 native riparian trees and shrub species, which will help to stabilize the shoreline, slow and absorb run-off, and improve wildlife habitat.
