LaHave River Watershed Project

2015 Field Report

Bluenose Coastal Action Foundation

April 2016

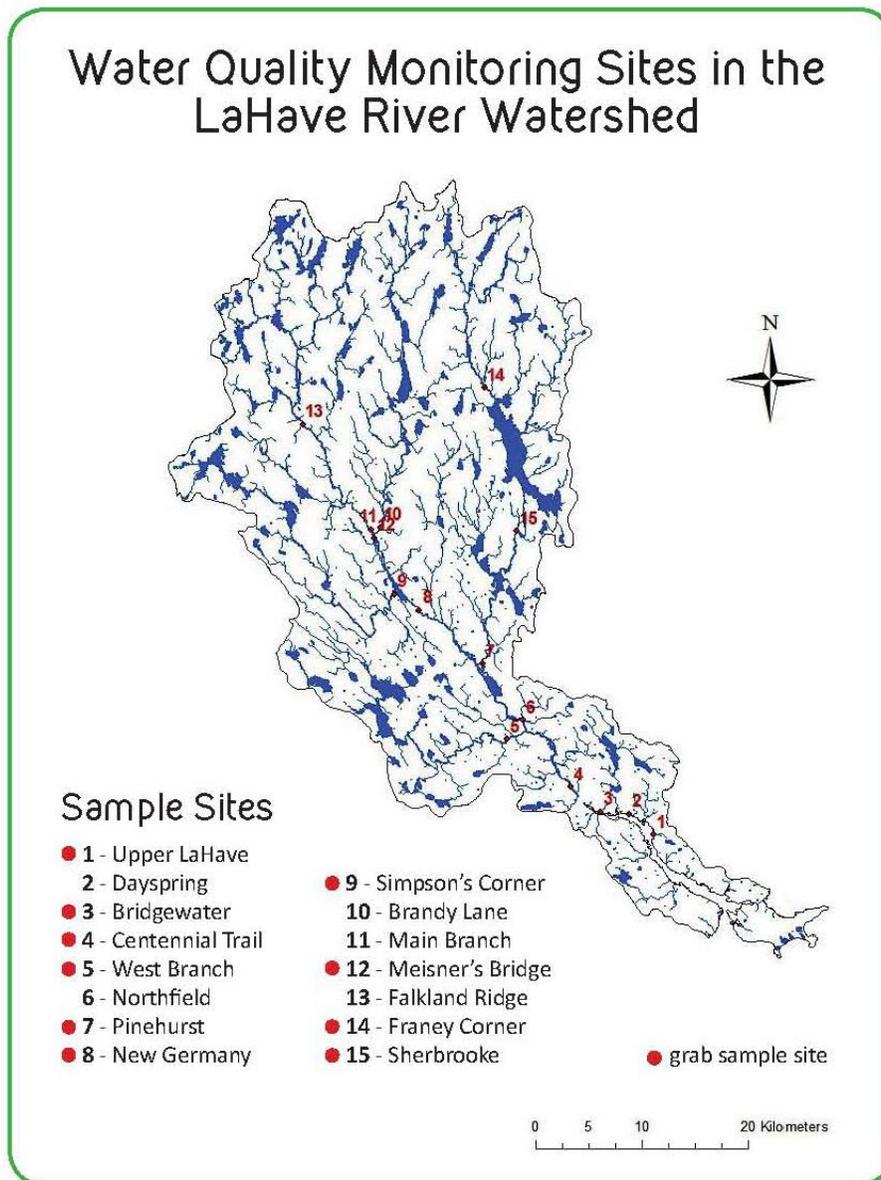
Figure 1 – Location of water quality sample sites in the LaHave River Watershed.

The health of the LaHave River is influenced by the interaction of air, land, and water throughout the entire watershed, which is why the water quality monitoring program was designed at a watershed scale. Fifteen sample sites were chosen in order to capture the water conditions throughout the entire watershed (see Fig. 1.0). Monitoring occurs from the headwaters to the estuary, including the confluence of each major sub-watershed branch, the

main stem of the river, and downstream of three waste-water treatment plants. These sites are monitored on a monthly basis for physical, chemical, and biological water quality parameters using a YSI Professional Plus water meter and through the collection of water samples for laboratory analysis. In addition, a total of 30 different metals are monitored on a bi-annual basis. With over 8 years of water quality data, the monitoring program has contributed greatly to our understanding of both the natural variability of the system and the environmental impacts of various activities throughout the watershed.

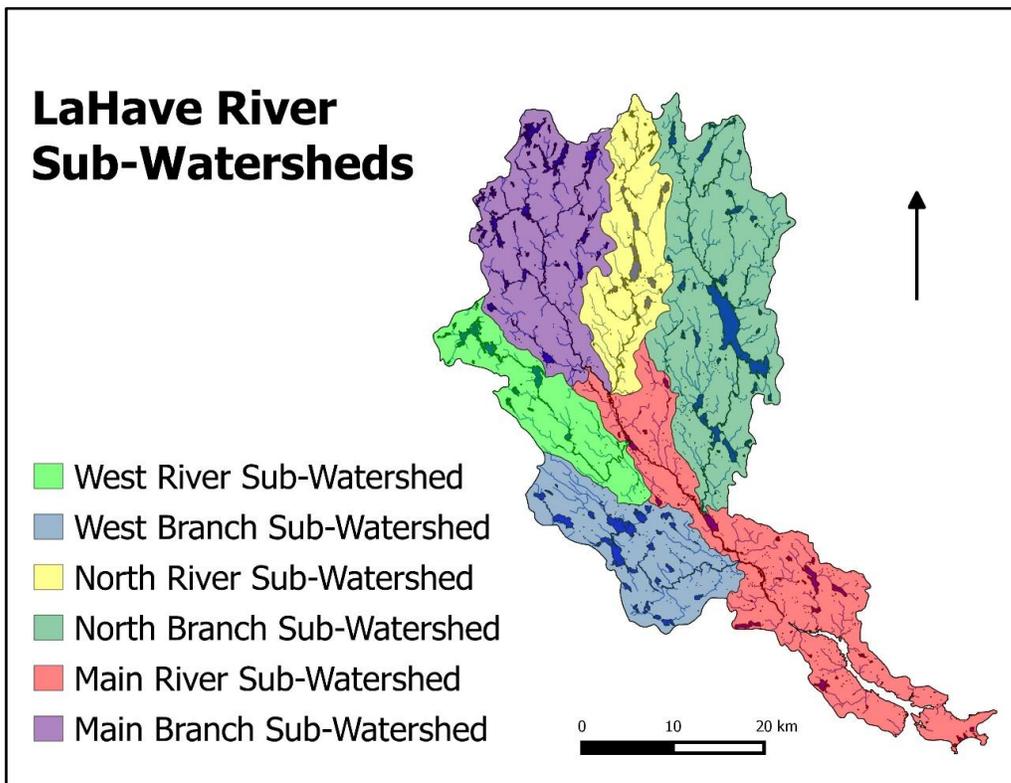
Figure 3 – Sub-watersheds of the LaHave River Watershed.

Due to the size and complexity of the watershed, habitat assessment and restoration efforts have been carried out at a more feasible sub-watershed scale (see Fig. 3.0). Sub-watershed Fish Habitat Restoration Plans have been developed for 4 of the 6 sub-watersheds (West River, West Branch, North Branch, and Main River), using a template created by Nova Scotia Salmon Association’s Adopt-A-Stream Program. These plans include background information on the ecological conditions of the area, assessments of riparian and in-stream habitat conditions, water quality monitoring, land-use surveys, aquatic connectivity assessments, and recommendations for future assessments and restoration activities needed to address harmful environmental impacts. This sub-watershed analysis improves our understanding of how water resources are being used, how land-use activities are influencing water quality, and how stream and riparian habitat conditions are influencing the quality and availability of fish habitat.

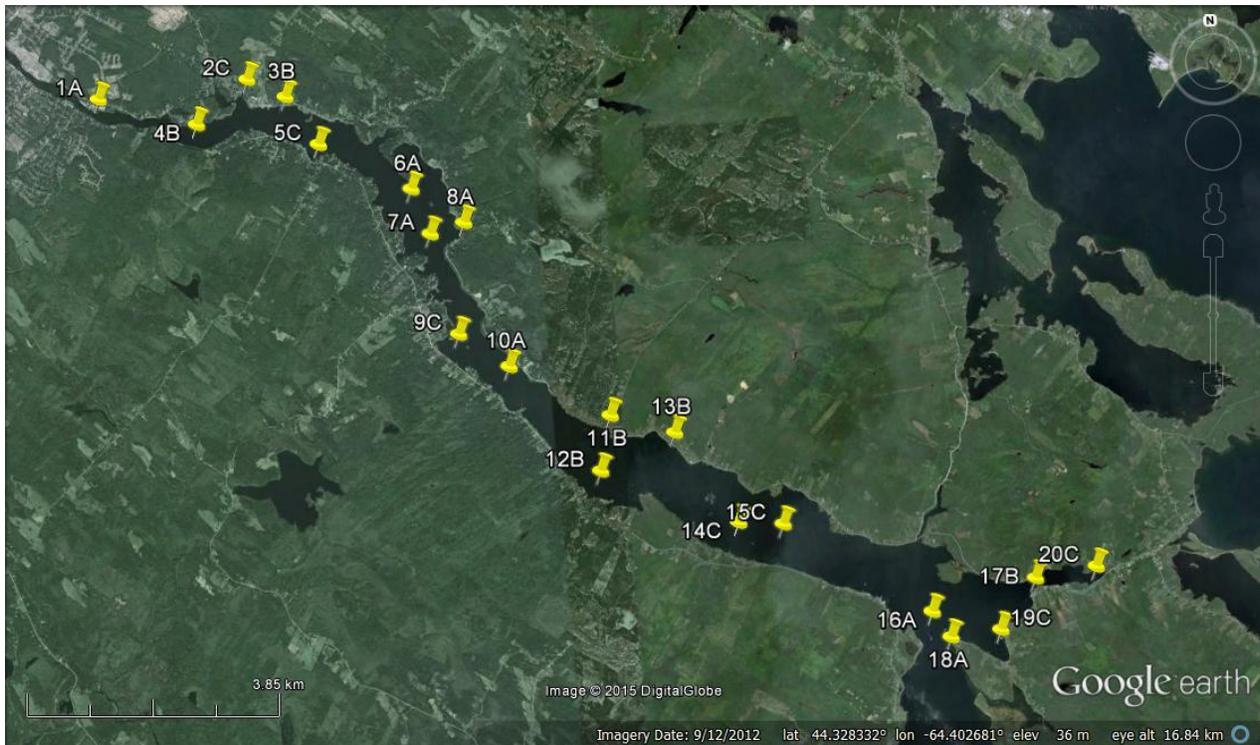
Figure 4 – Location of sample sites for the LaHave River Estuary Health Assessment Project.

An estuary health assessment project was completed in the LaHave River Estuary in 2015. This project was carried out in partnership with several environmental organizations across Atlantic Canada, with Eastern Charlotte Waterways Inc., in Blacks Harbour, NB, acting as the project lead. Each partner organization assessed the health of their local estuary by monitoring for bacteria levels, general water quality, contaminants in sediment, eutrophication indicators, and aquatic biodiversity at multiple sample sites (see Fig. 4.0). Results from this project will be used to produce an Estuary Health Report Card for the LaHave River Estuary, and the reports from each organization will be compiled to develop a Report on the State of Estuary Health in Atlantic Canada.

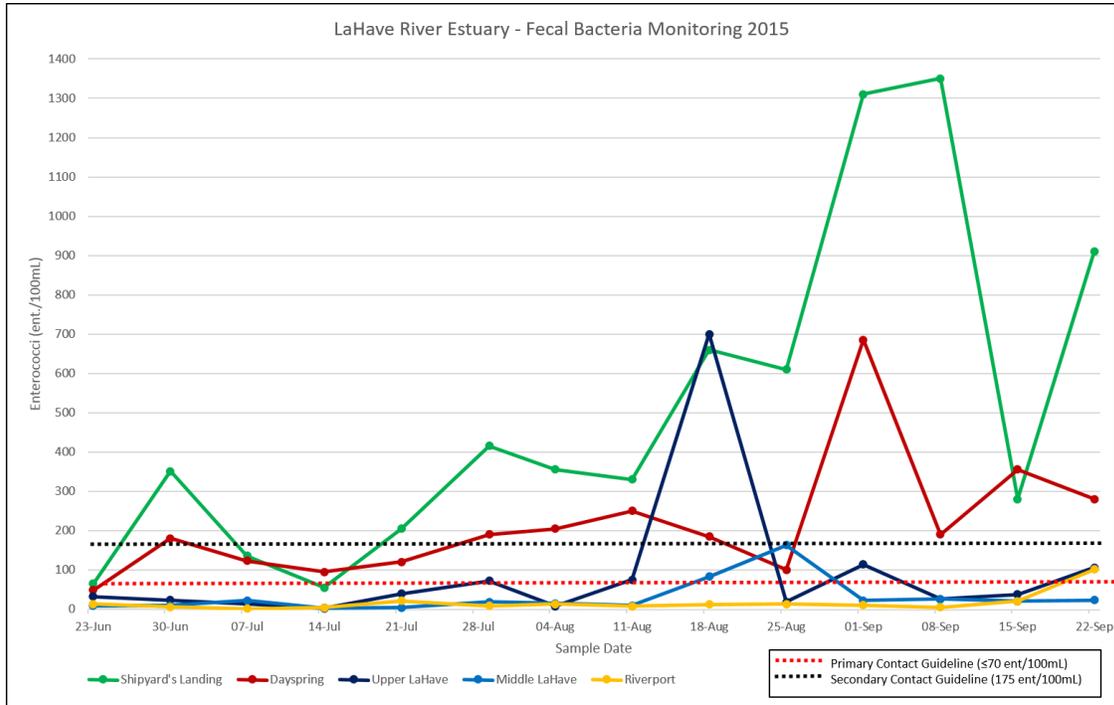
Figure 5 – Fecal bacteria monitoring results from five locations in the LaHave River Estuary.

Coastal Action, in partnership with a group of volunteers called the Straight Pipe Citizens Group, has been collecting water samples from 5 shoreline locations throughout the estuary on a weekly basis during the summers of 2014 and 2015. These water samples were analyzed for enterococci, which are the most appropriate indicator of fecal contamination in marine recreational waters. The results of this monitoring showed several exceedances of Health Canada’s Guidelines for Canadian Recreational Water Quality for both primary contact (where ingesting water is likely) and secondary contact (where ingestion is possible but not likely) (see Fig. 5.0).

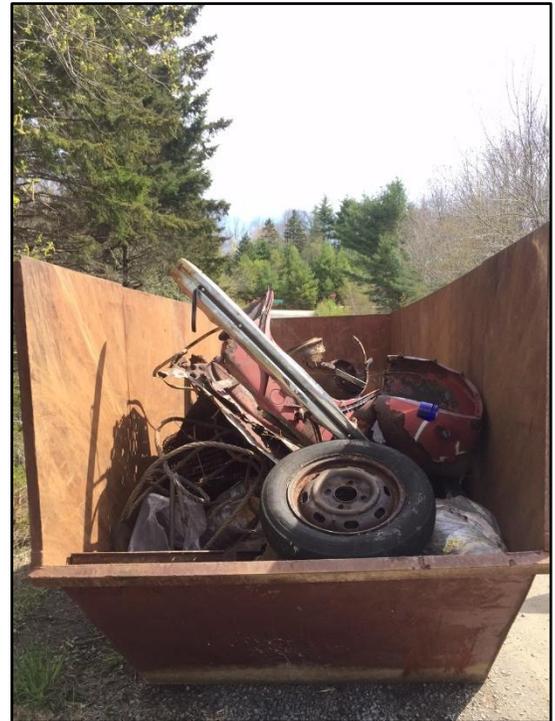
Figure 6 – Garbage removed from riparian and in-stream habitats in West Branch tributary.

Every year, the LRWP field crew works to improve fish habitat in the watershed through various restoration activities. In 2015, fish habitat restoration projects were completed in the West Branch and Main River Sub-watersheds. Work in the West Branch Sub-watershed involved a 600 m tributary between New Canada Lake and Wagner Lake. This stream had aquatic connectivity issues and a significant amount of garbage in the stream and throughout the riparian habitat. A debris blockage was removed from the outlet of New Canada Lake to improve fish passage between the stream and the lake. Garbage was removed from 20,000 m² of riparian and in-stream habitat, including over 1,000 lbs of scrap metal (see Fig. 6.0). A culvert assessment was performed on a wooden box culvert on the stream and it was determined to be posing a barrier to fish migration. In order to restore fish passage through this culvert, the field crew installed 4 wooden baffles inside the culvert as well as a weir and chute system at the outflow, with the assistance of our project partner, Nova Scotia Salmon Association’s Adopt-A-Stream Program (see Fig. 7.0). This project has improved fish habitat conditions in the stream and the health of the riparian zone, as well as restored fish passage to 3,000 m² of in-stream habitat and a 41.6 ha lake.

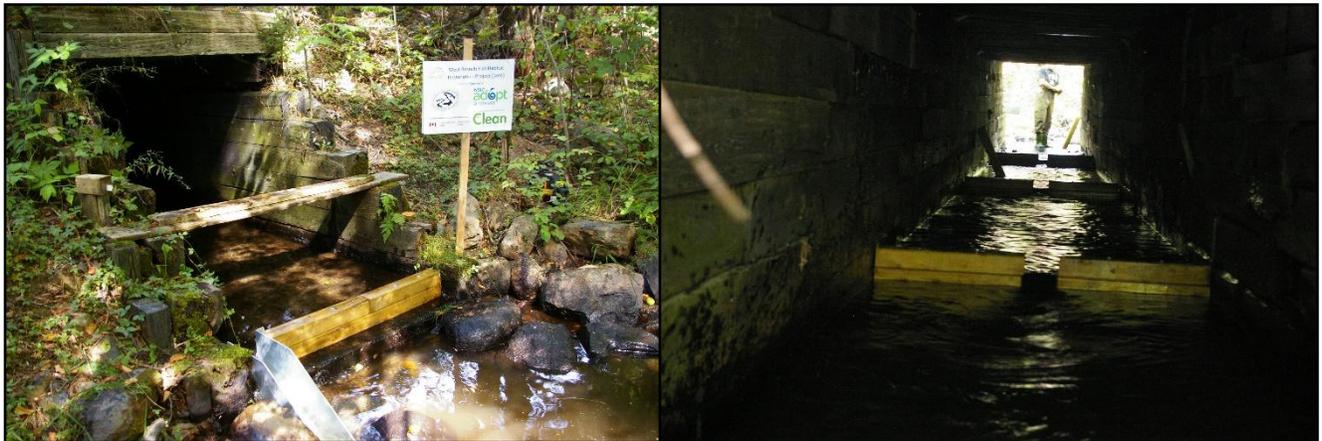
Figure 7 – Restoring fish passage through the installation of a weir, chute (left), and baffles (right).

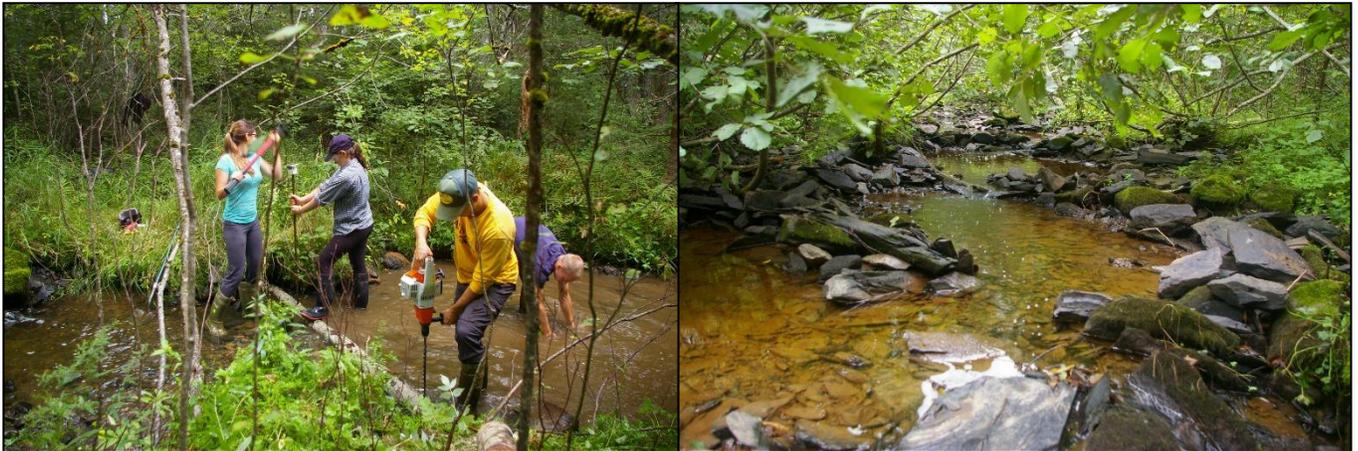
Figure 8 – Installation of a digger log (left) and enhancement of step-pool habitat (right) at Ross Brook.

Fish habitat restoration work in the Main River Sub-watershed was conducted in Ross Brook, a 5 km tributary of the main LaHave River. Restoration work took place along a 500 m stretch of the stream, near its headwaters. This area suffers from sedimentation as a result of an upstream pasture that allows cattle direct access to the stream. Restoration work at this site included alder thinning, debris blockage removal, step pool habitat enhancement, and the installation of two digger logs and one deflector (see Fig. 8.0). These activities have helped to reduce the sediment load in the stream, and restore over 2,500 m² of fish habitat. Further restoration work is planned for Ross Brook in 2016, involving a culvert restoration project where this stream crosses under the Trunk 10 Highway. Restoring fish passage at this location, near the confluence of Ross Brook with the main LaHave River, will improve access to the entire 5 km length of this stream for fish populations.

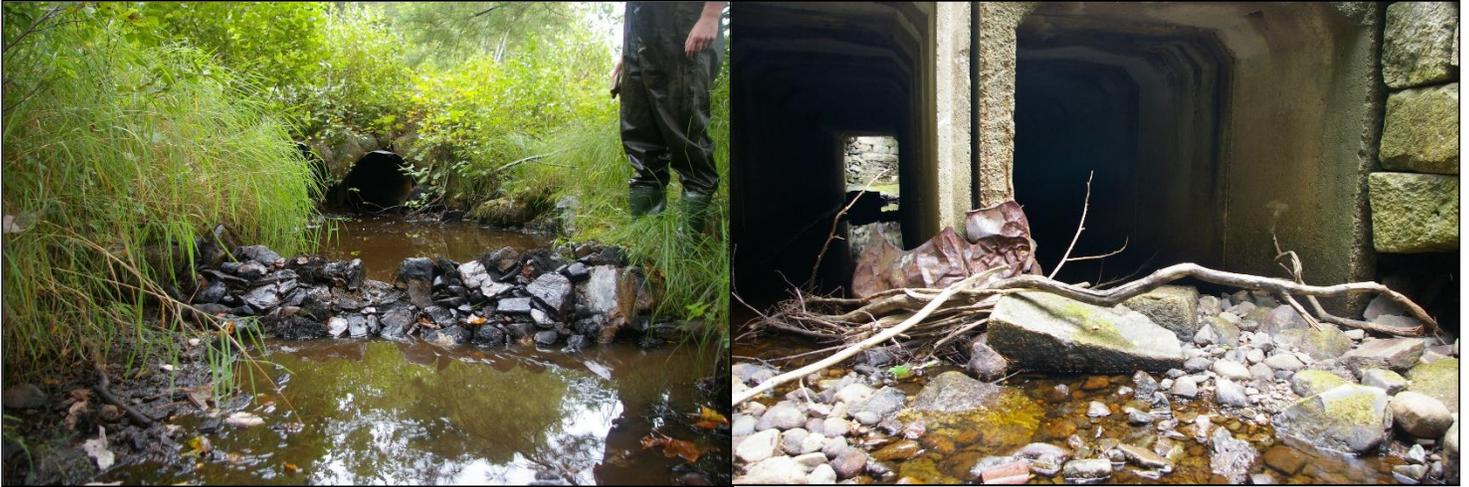
Figure 11 – Two culverts restored on Cooks Brook by installing a tailwater control (left) and removing a debris blockage (right).

The LRWP field crew began assessing aquatic connectivity throughout the watershed in 2015, starting with the Main River Sub-watershed. Over 150 stream crossings were assessed and 52 culvert assessments were performed to identify crossings which do not allow fish to migrate up/downstream to access the various habitats they need throughout their life cycles. These assessments have identified a number of full and partial barriers to fish migration (see Fig. 9.0). Four of these barriers were chosen for remediation in 2015; two culverts on Hebb Brook (see Fig. 10.0) and two culverts on Cooks Brook (see Fig. 11.0). By removing debris blockages and installing baffles, chutes, and weirs in these culverts, access has been restored to 12,900 m (72,600 m²) of stream habitat for local fish populations.
