Fall 2016

American (Silver) Eel in East River, Chester

Danielle Pernette

Bluenose Coastal Action Foundation

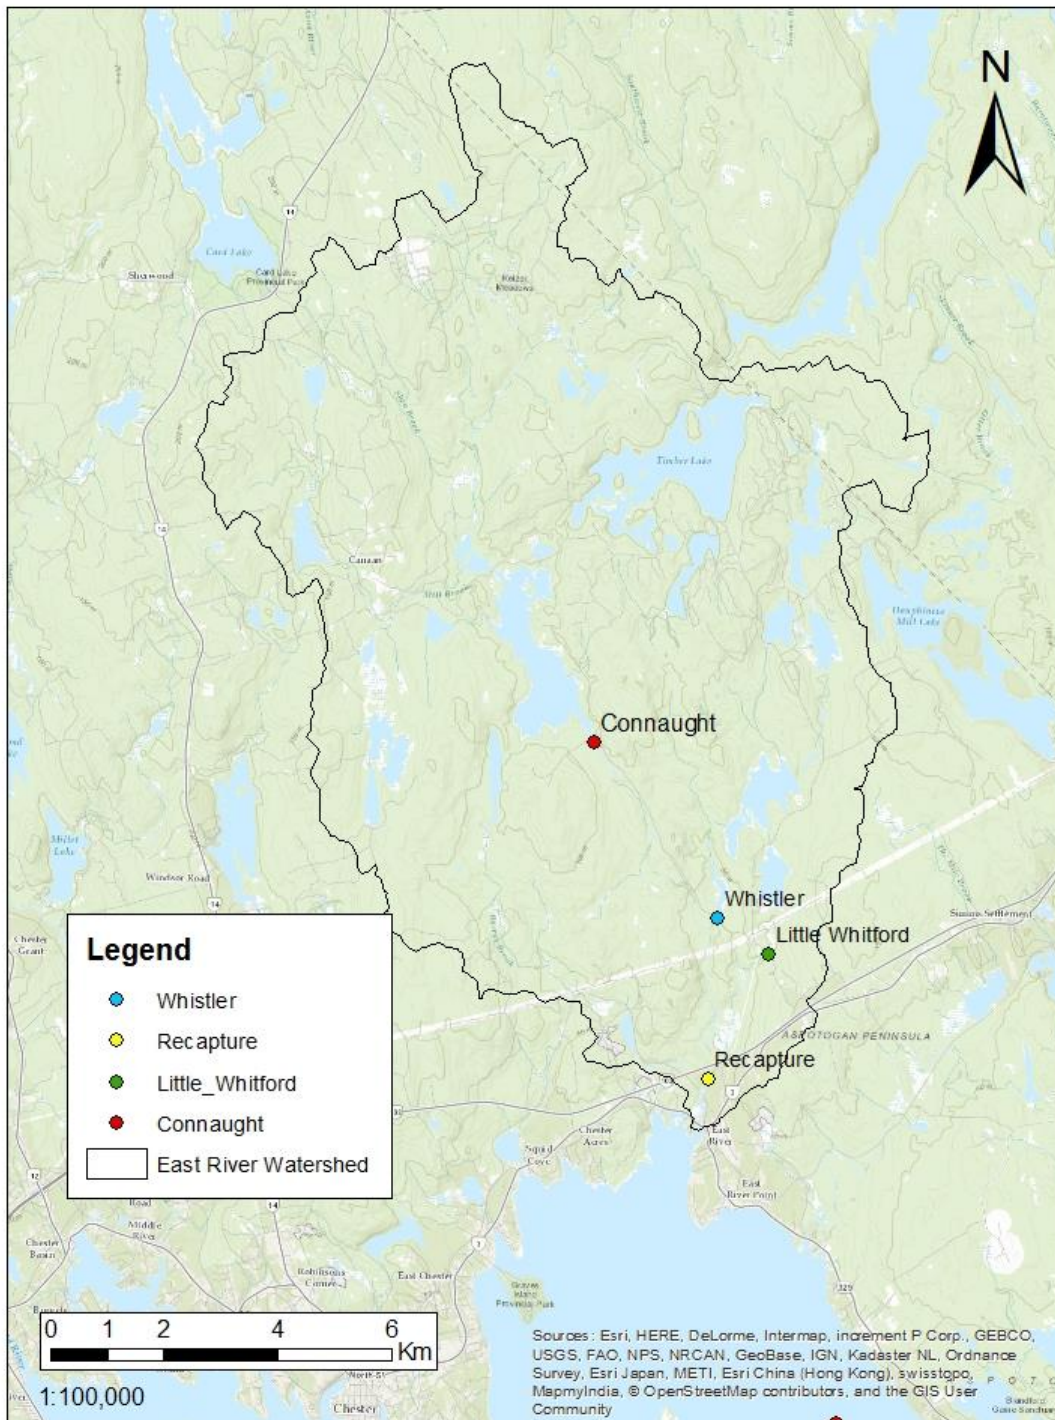
Figure 3: Map of ER-C watershed area showing trap locations.

The trap sites were mapped (Figure 3) and the approximate distances between each trap site and the recapture site were estimate using ArcGIS (Graphic Information Systems). The estimated distance between Connaught Lake, Little Whitford Lake, and Whistler Lake to the recapture trap are 8.43 km, 4.22 km, and 3.34 km respectively.

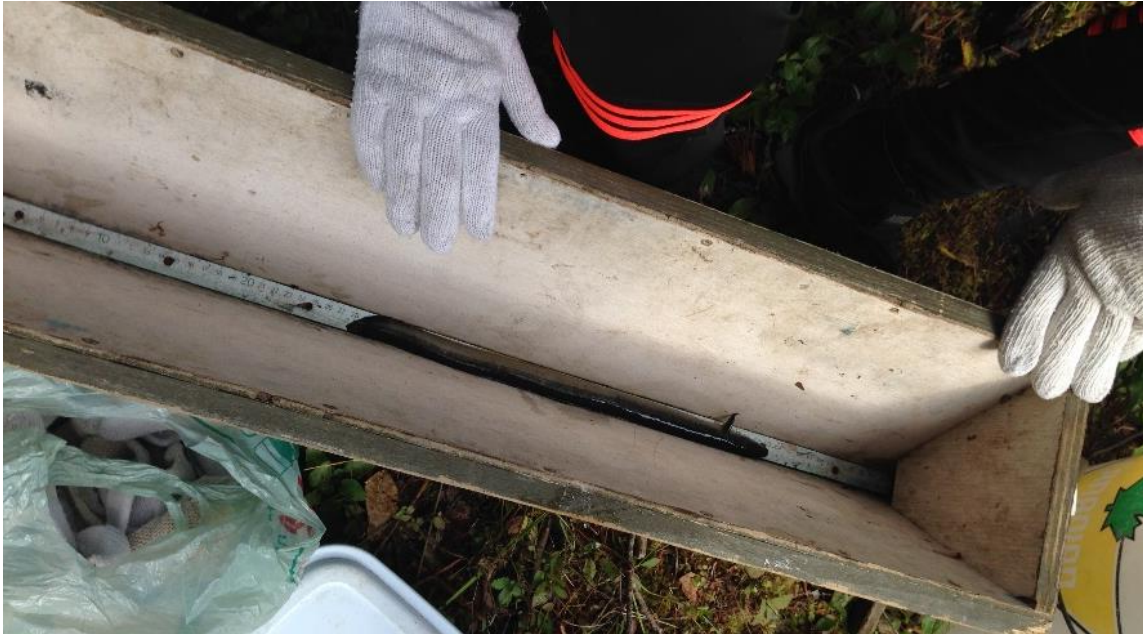
Figure 4: Eel measuring trough.

The priority at all trap sites was to gather length measurements and colouring, or phase, of each individual fish. Every eel captured was measured to length in millimetres, using an eel trough (Figure 4).

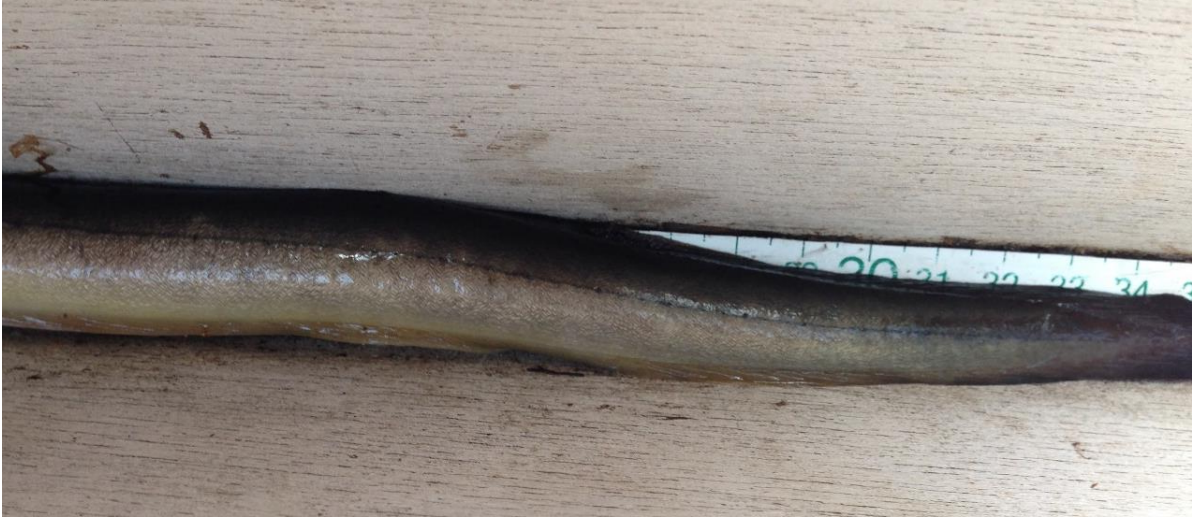
Figure 5: Photo showing black corpuscles along lateral line, and silver colouring along ventral surface and up to the lateral line, indicating a silver phase eel.

Colour, or phase, was determined using qualitative colouring criteria based on research criteria for European eel¹. The lateral line of each eel was visually examined to determine differentiation; i.e., the formation of black corpuscles along the lateral line, 1-2 cm apart. If at least one black corpuscle was present, the eel was given a score of 1, indicating differentiation of the lateral line; if there were no black corpuscles present, the eel scored a zero. The colour of each eel was also used to determine the phase of each fish. If the eel was silver or shimmery in colour from the ventral surface to the lateral line, the eel scored 1. If the colouring was more yellow, and did not continue to the lateral line, the eel scored zero. If the total score of the eel was zero, the eel was recorded as yellow. If the eel scored in both the lateral line and colouring criteria, for a score of 2, the eel was recorded as silver (Figure 5). If the total score of the eel was only 1, meaning the eel only had one of the silvering criteria, the eel was recorded as in the process of silvering.

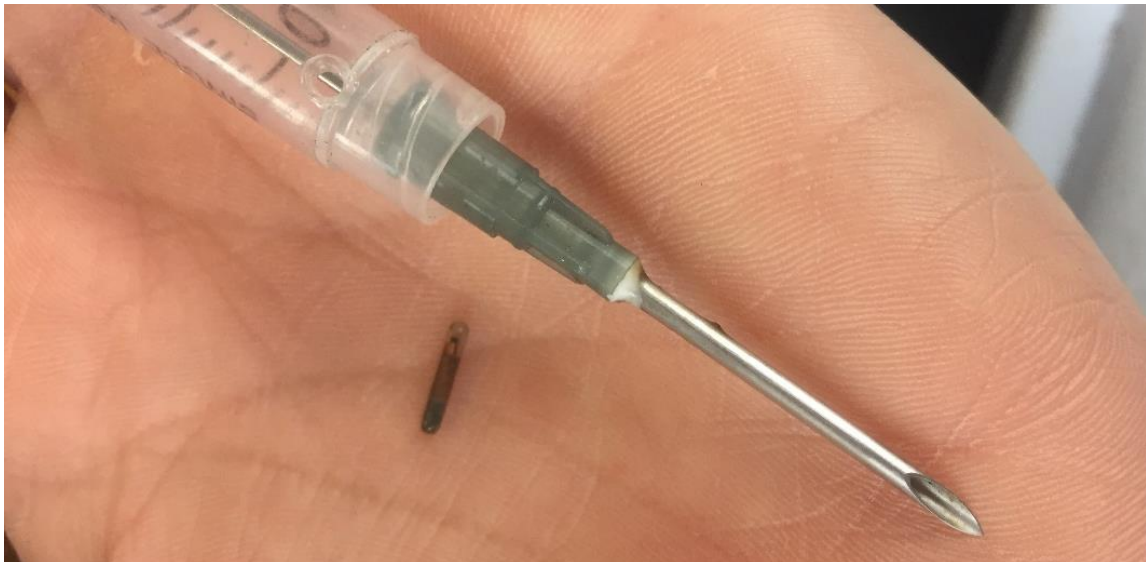
Figure 6: PIT (Passive Integrated Transponder) tag and injector.

American eel captured at any of the three upstream sites were marked with a Passive Integrated Transponder (PIT) tag (Figure 6), each having an individual number, making the eel identifiable. The PIT tags were placed just ahead of the dorsal fin, halfway to the lateral line (Figure 7). Each eel was scanned to ensure there was not an already existing PIT tag, as occasionally eel find their way into the same trap more than once. Every eel caught at the recapture site was scanned to determine if it was recaptured from upstream.

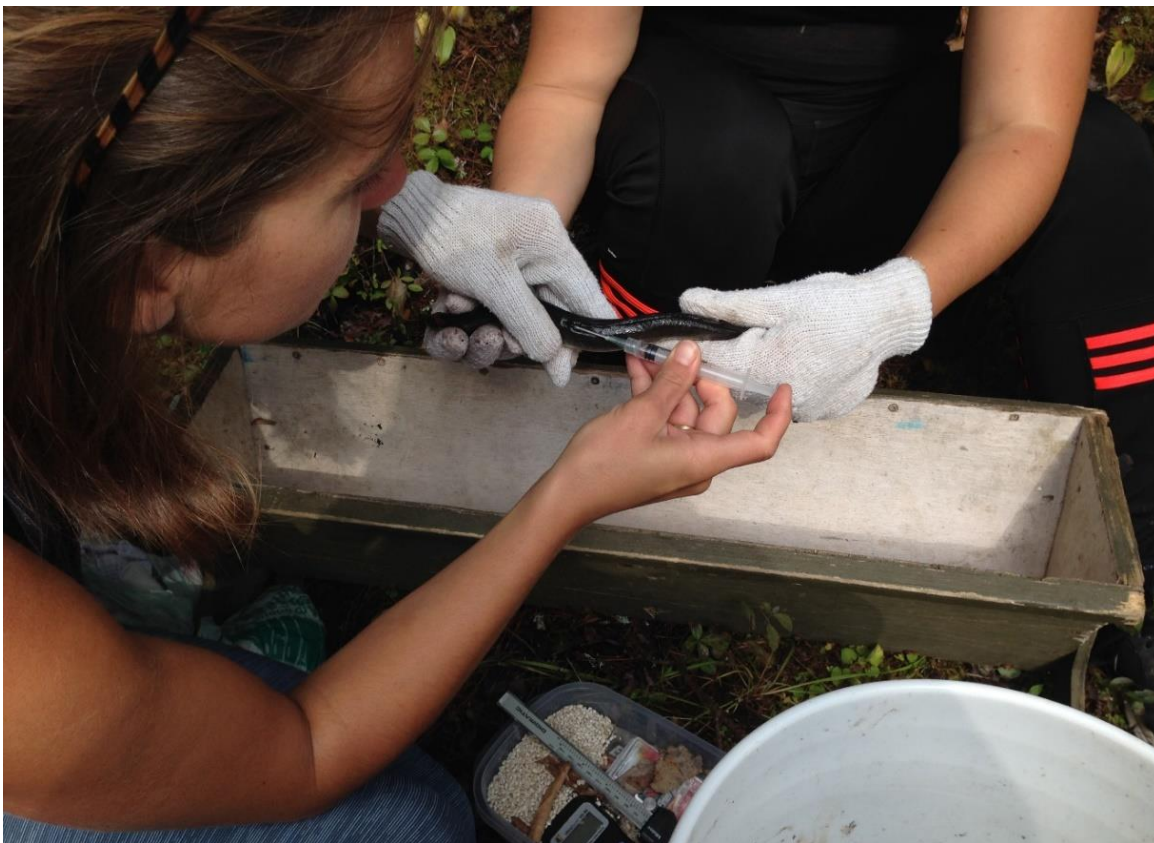
Figure 7: Injecting an eel with a PIT tag.

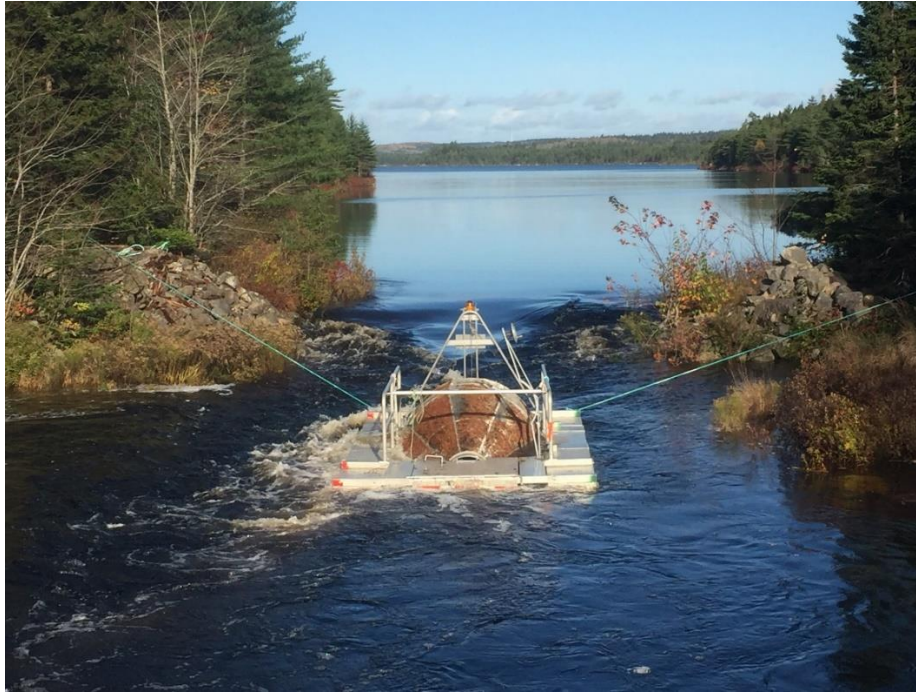
Figure 8: Rotary Screw Trap (RST) at Connaught Lake outflow in 2016 (Coastal Action photo: October 24, 2016).

A Rotary Screw Trap (RST) was installed in the outflow of Connaught Lake from September 22 until November 3 (Figure 8). The RST was assembled and installed by Coastal Action staff, and securely tied to the shore in such a way that it would catch most of the current flowing from Connaught Lake. The holding box was emptied with a dip net, and any fish other than eel that were caught were recorded in the field notes and released immediately. The RST used in the previous year was a slightly different smaller model, with a 5' diameter drum, whereas this year was larger with an 8' drum.

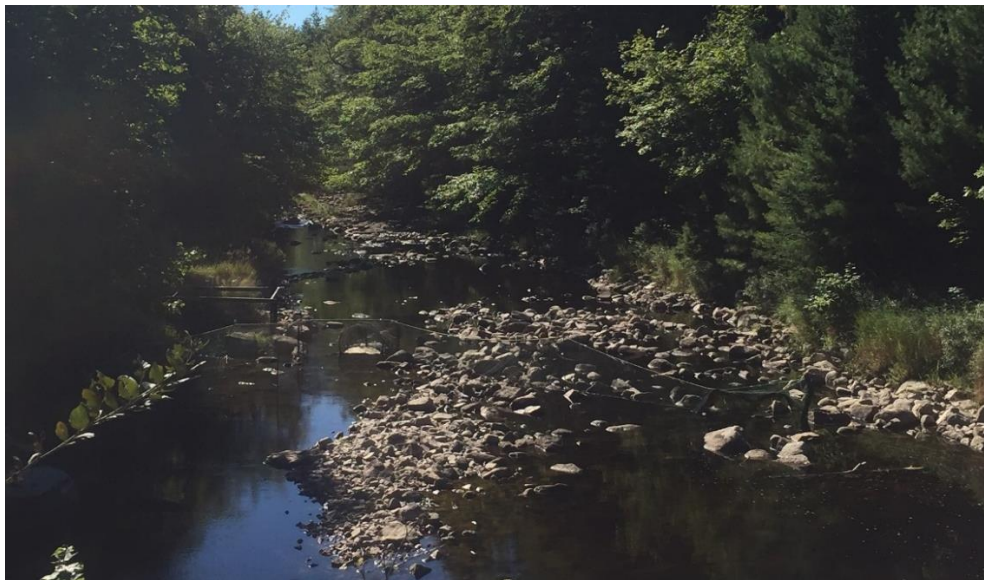
Figure 9: The large fyke net installed early in the season, when water levels were too low to turn the RST (Coastal Action photo: September 16, 2016).

Due to low water levels at the beginning of the season, fyke nets (Figures 9 and 10) were placed below the RST site from August 29 to October 10, at which point the RST began fishing when water levels had risen enough to rotate the drum. After October 22, heavy rains fell and flooded the Connaught site for several days (Figure 11), resulting in no catches.

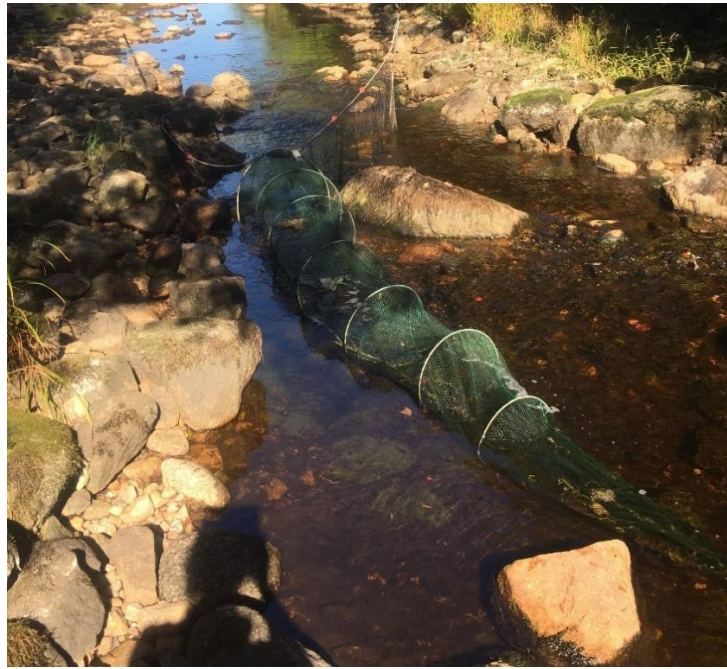
Figure 10: Smaller fyke net placed downstream in a stronger current, after finding the larger fyke net was inefficient (Coastal Action photo: October 6, 2016).

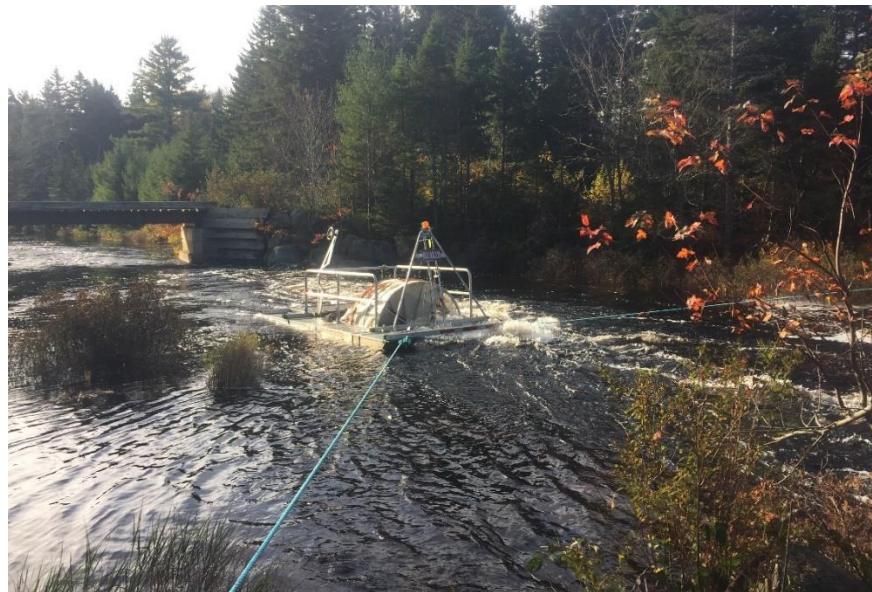
Figure 11: Flooded RST after heavy rainfall (Coastal Action photo: October 22, 2016).

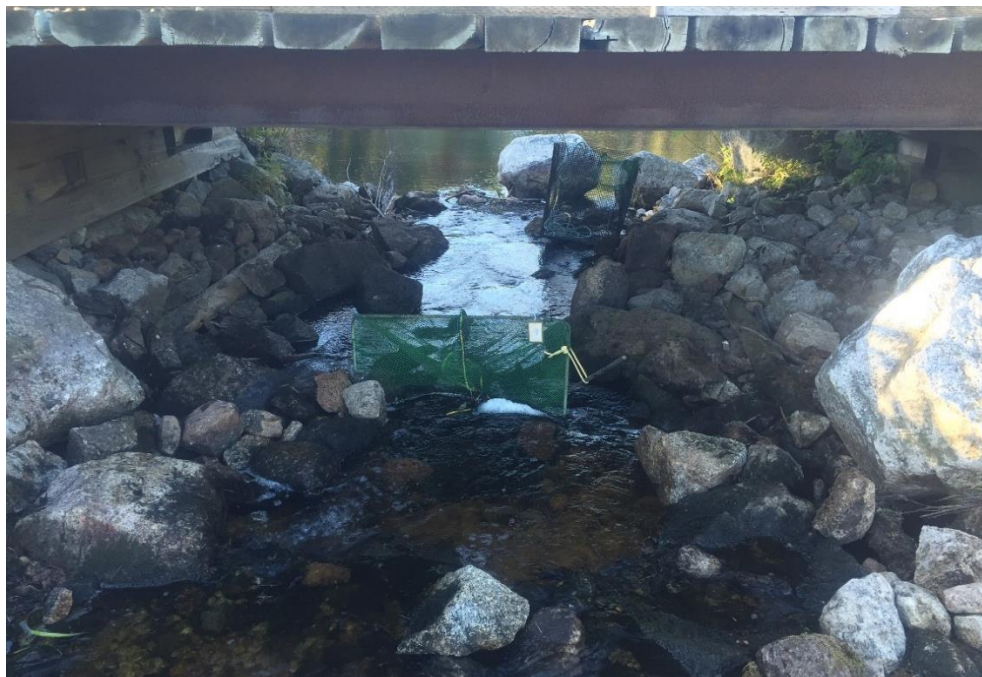
Figure 13: Whistler Lake outflow fyke net at the first site beneath the bridge during low water level (Coastal Action photo: September 15, 2016).

A fyke net was placed in the outflow of Whistler Lake from August 29 to November 4. The outflow of the lake is wide, tapering to a funnel beneath a bridge before opening into a pool. The fyke net was originally set directly below the bridge (Figure 13), but as water levels rose, the trap was moved around the outflow several times throughout the season attempting to increase catches and avoid trap blow out. The fyke net consisted of two small wings, an apron, and a funnel to help guide fish into the trap.

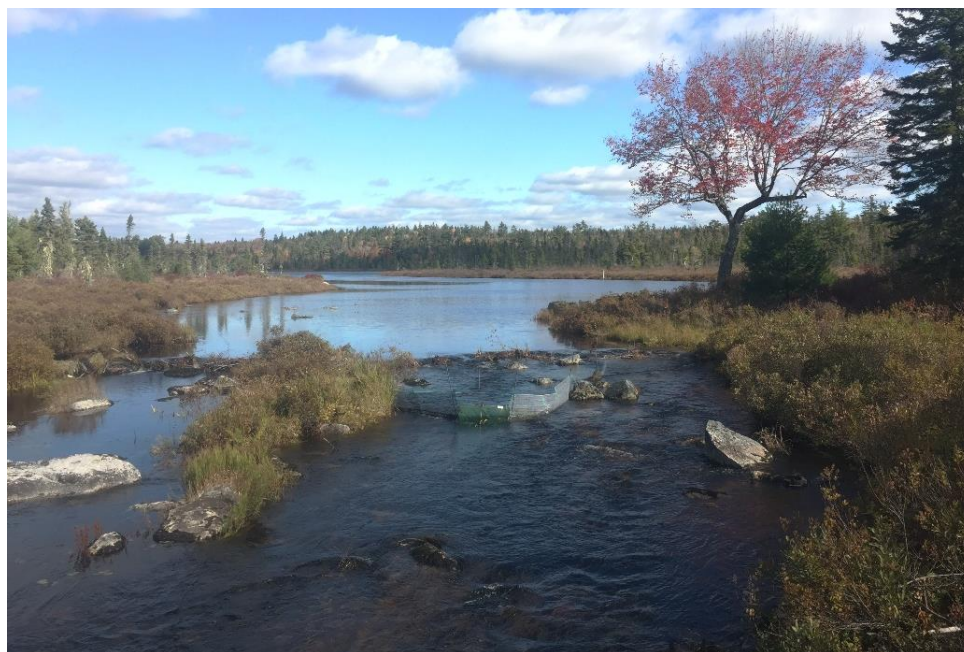
Figure 14: Whistler Lake outflow trap site later in the season, with a wing on the right, after water levels rose (Coastal Action photo: October 17, 2016).

Late in the season, another wing was added in an attempt to capture more water flow and deflect eel into the trap (Figure 14).

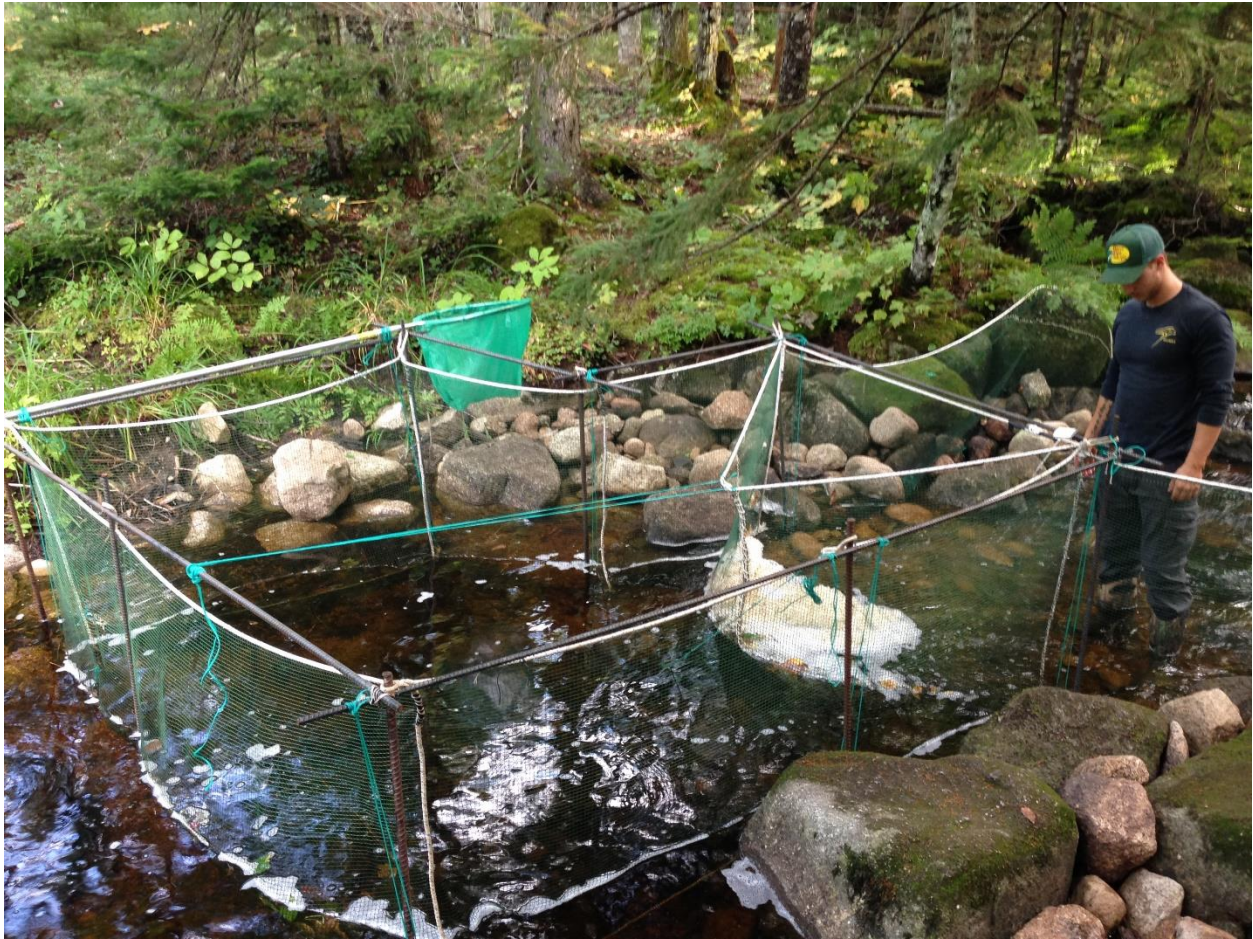
Figure 15: Recapture net being set (Coastal Action photo: August 29, 2016).

The recapture trap net, also used in 2015, was set up in the same location as in past years, in a side branch of the main river below the confluence of the East and Canaan Branches. The trap was in place from August 29 to October 24, and was held in place with one-inch rebar driven into the stream bed and tied perpendicular to create a frame. To make it easier to fish and set the trap, durable rope was used to create a pulley system, allowing the bottom of the net to be lifted and lowered (Figure 15). The wings were long, stretched to either side of the channel, essentially catching the width of the stream. A modification to the trap in 2016 included a plastic funnel at the opening of the trap, to make it more difficult for eel to swim back out. Three leaf catchers were added upstream to try to deflect and relieve some of the pressure from leaf buildup (Figure 16). The leaf catchers were made of half-inch plastic hardware cloth and three-inch wire mesh held in place with rebar.

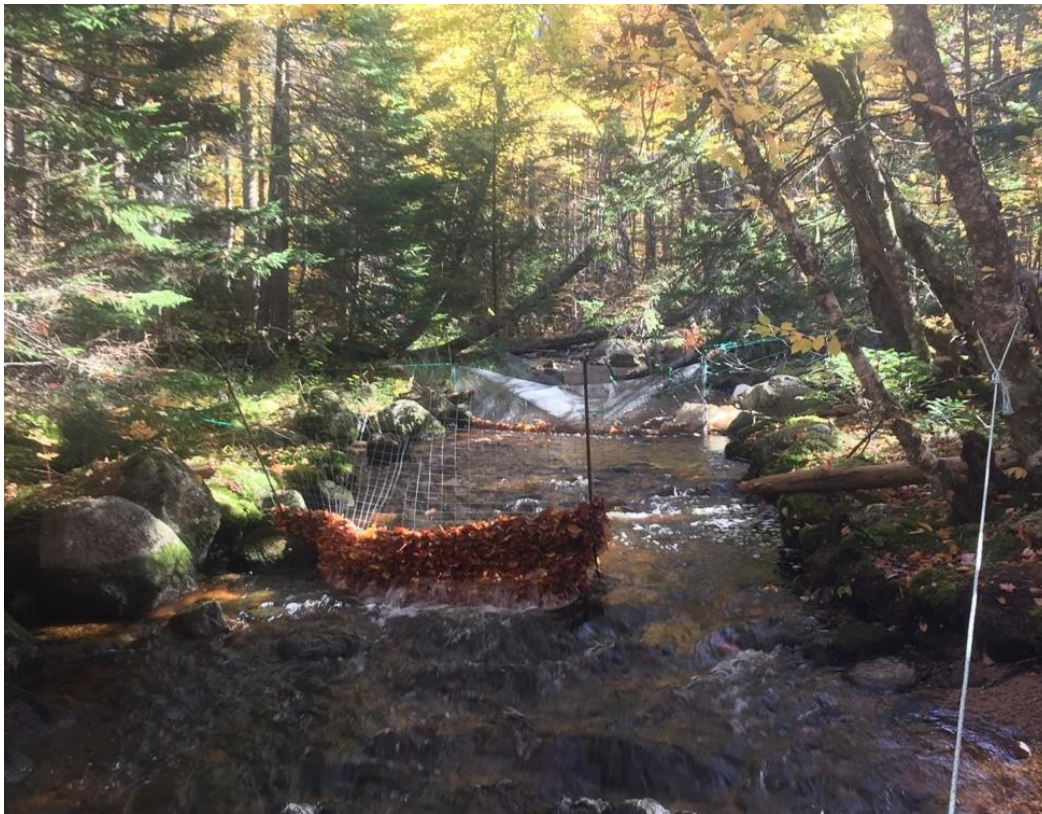
Figure 16: Three leaf catchers set above the recapture trap (Coastal Action photo: October 18, 2016).

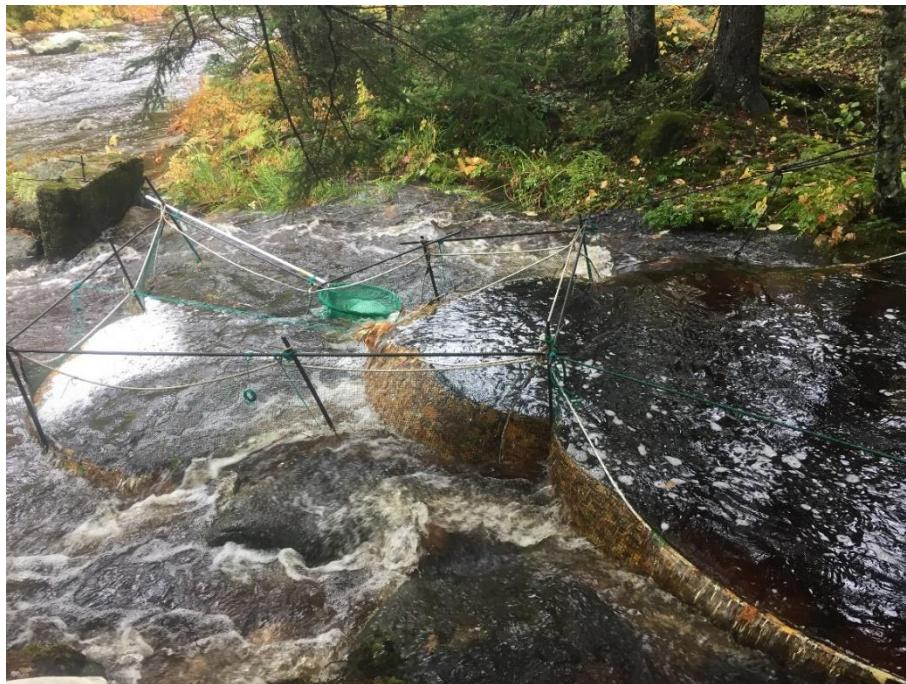
Figure 17: Recapture net showing leaf build up (October 19, 2016).

Towards the end of the season, leaves quickly became a problem (Figure 17), along with high water levels (Figures 18 and 19). The trap became overflowing with water, even without leaves, forcing the season to come to an abrupt end at the recapture site on October 24.

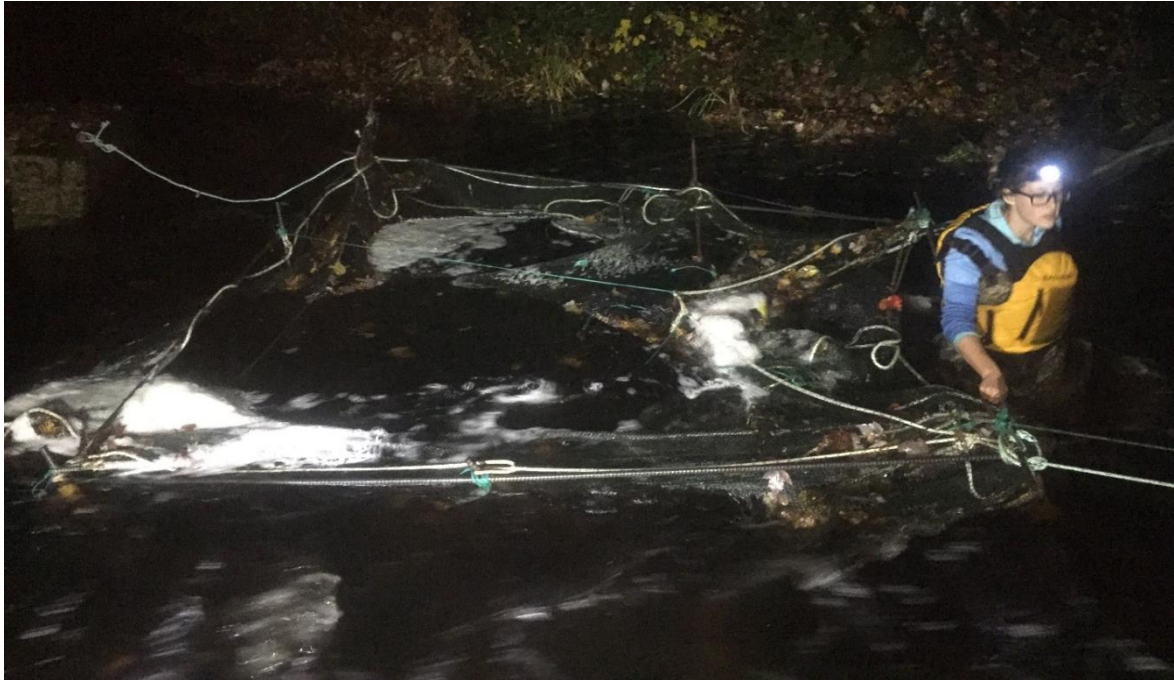
Figure 18: High water levels overflowing recapture trap (Coastal Action photo: October 22, 2016).

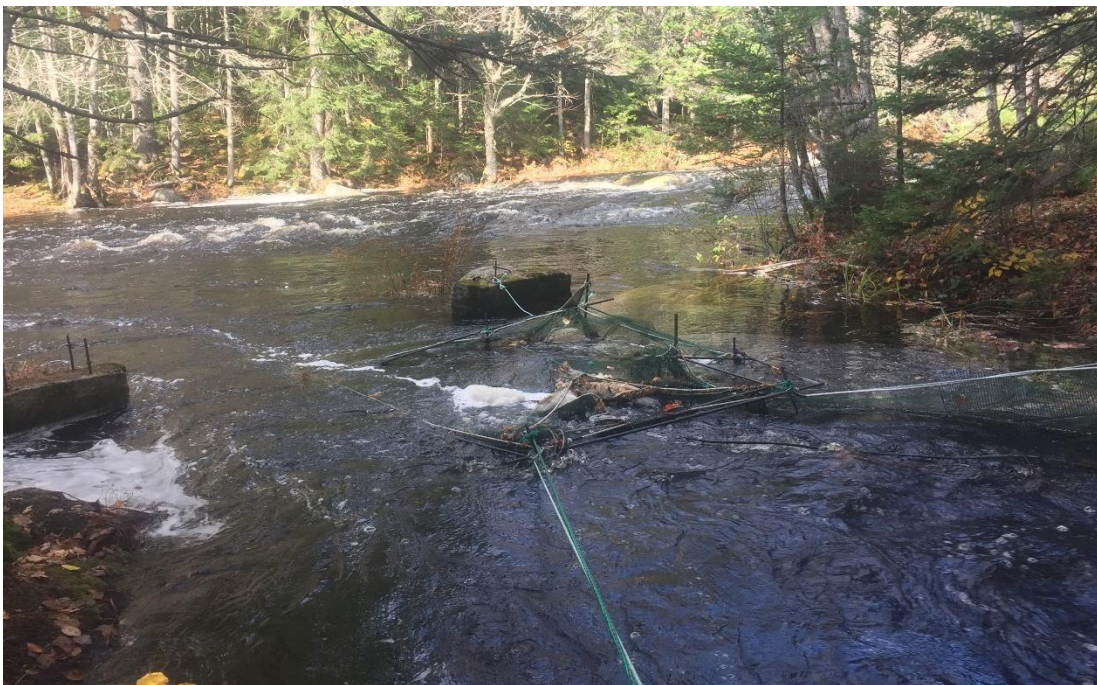
Figure 19: Recapture site after significant rainfall (Coastal Action photo: October 24, 2016).

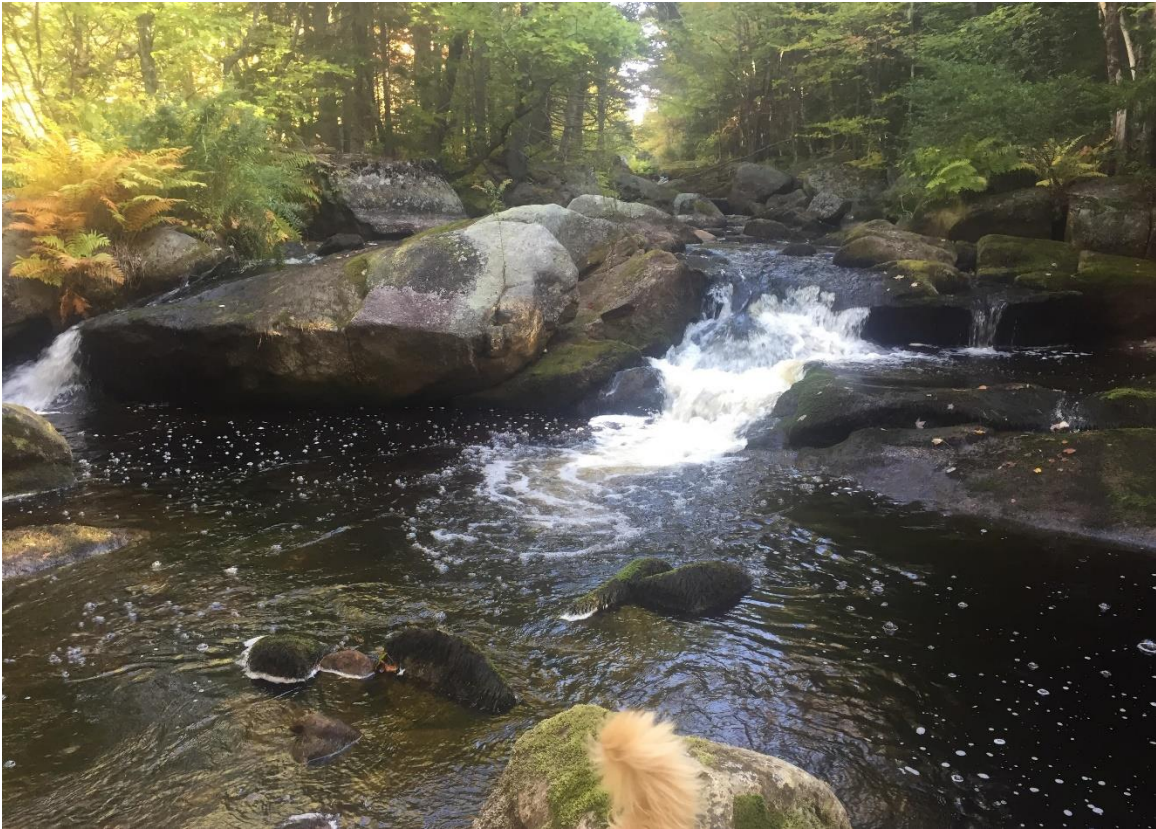
Figure 20: East River, Chester falls above the recapture site (October 4, 2016). Most of the water is redirected to the left channel, while the recapture site is to the right, downstream. Less water flow to the trap means less eel moving towards the trap.

Just a couple hundred metres upstream from the recapture site, a waterfall exists where the river splits into several directions before rejoining below the recapture site. The recapture site is in one of the branches leading from this split in the river. During low water conditions, it was observed that almost all the water was being channeled down another branch, with only a very small fraction flowing down to the recapture site (Figures 20 and 21). This means that until water levels came up significantly on October 10, most, if not all, of the eel moving downstream were likely channeled away from the trap as they move with the current. Once the water levels came up, the pressure on the recapture net was so strong that the bottom of the net was lifted off the stream bed, allowing eel to pass under the net rather than become captured. In addition to high water levels, leaves were once again an issue at the recapture site, increasing pressure on the net. Although the installation of three leaf catchers upstream helped to relieve some pressure from the net, the site was visited between one to three times a day just to empty leaves. As the site is about a one kilometre hike in, extra hands helping with leaves was much appreciated and necessary.

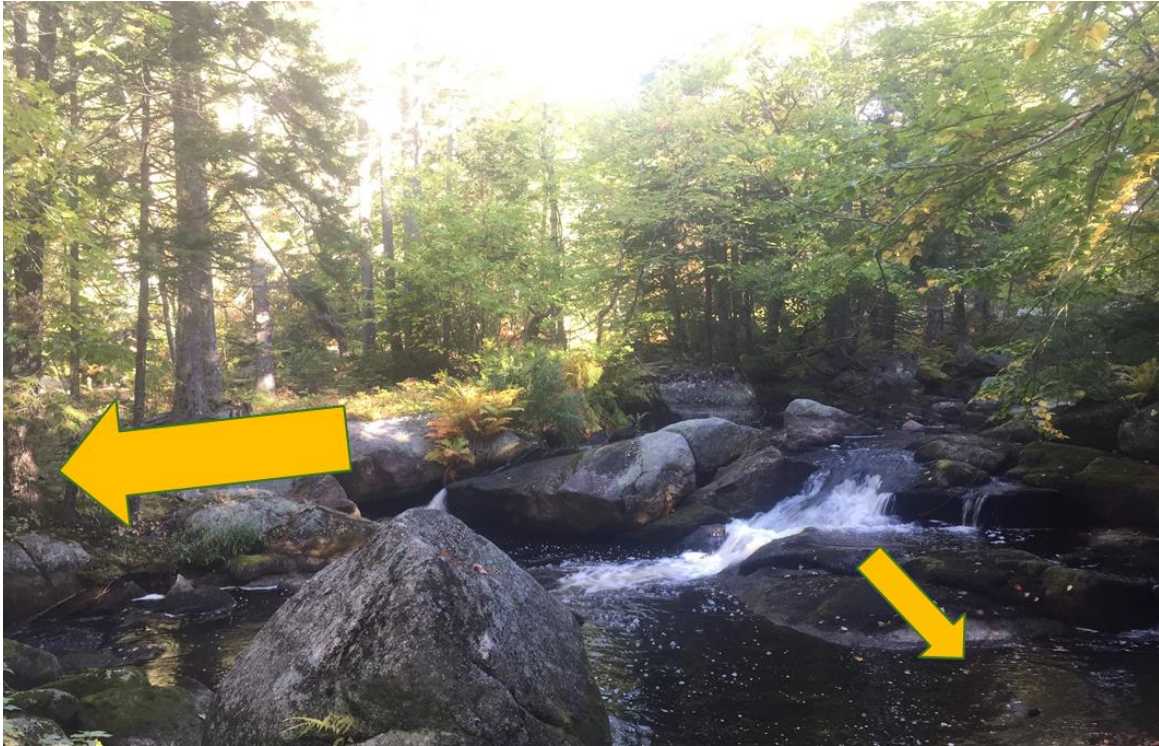
Figure 21: East River, Chester falls above recapture site showing most of the water at low flow is redirected down the channel to the left, away from the recapture site which is to the right (October 4, 2016).
