2021-22 Review of Fisheries Activities for the Recovery of Endangered Atlantic Whitefish and Southern Uplands Atlantic Salmon in Nova Scotia

May 2022

2021-22 Review of Fisheries Activities for the Atlantic Whitefish Recovery Project: "Recovery of Endangered Atlantic Whitefish and Southern Uplands Atlantic Salmon in Nova Scotia"

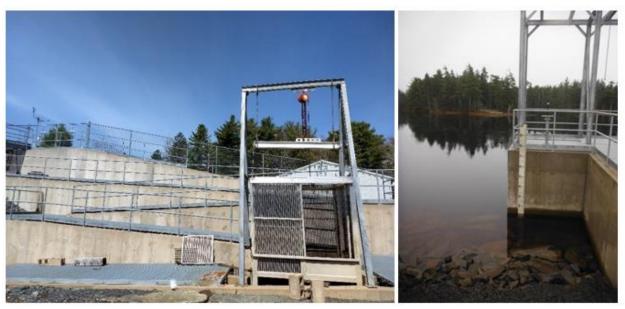
Figure 2. Left - Hebb Dam Fish Passage Trap lifted out of passage with door open. Right - Hebb Dam water level gauge near fishway exit.

The Hebb Lake Dam Fish Passage Trap Facility (Figure 2) was opened by Coastal Action staff on April 30, 2021, and was operated until June 30, 2021, to facilitate and monitor the upstream migration of gaspereau. The fish passage, or fishway, trap consists of a suspended  $6'0" \times 6'8" \times 7'8"$  aluminum box that is deployed in the fishway to intercept any fish that are migrating upstream into Hebb Lake. Water temperature and level were recorded each day.

During operation, the trap was lifted at least once per day and twice per day when there were high numbers of gaspereau. The trap was opened using its front sliding door and each native captured fish was netted and transferred into the fishway upstream of the trap if permitted, where they would be free to continue upstream into Hebb Lake. All native fish species were permitted to pass upstream, except for sea lamprey (*Petromyzon marinus*), which were released downstream of Hebb Dam as the monitoring protocols ensured that any fish entering Hebb Lake would not pose a risk to Atlantic whitefish.

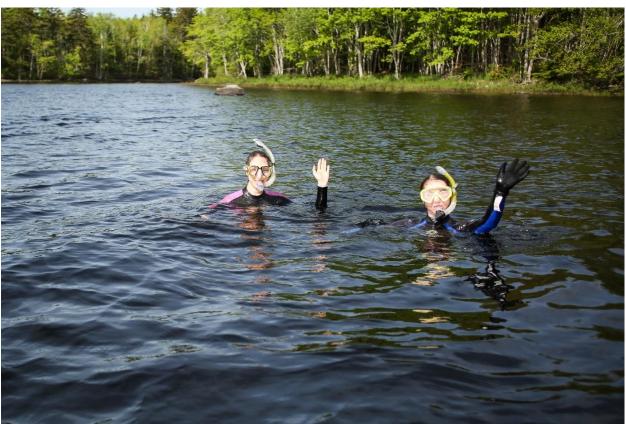
Figure 3. Snorkellers survey smallmouth bass nests along the rocky shoreline of Demone Cove in Milipsigate Lake in June 2021.

In previous years, surveys were conducted visually from a boat along the shorelines of the coves using Rickly Hydrological Co. AquaScope II viewers. In 2021, surveys were conducted by snorkelling to increase efficiency in identifying and destroying bass nests (Figure 3). Surveys were conducted with a boat operator and at least one snorkeller and on one day, two teams were deployed.

As nests were identified by the snorkellers, the nest class and the presence of males guarding the nest were recorded along with locations using a Garmin eTrex 10 handheld GPS unit (Table 3). Once nest details were recorded, the male nest guard was angled off the nest (if present) by the boat operator, and the nest was destroyed by the snorkellers using their hands to disturb the substrate.

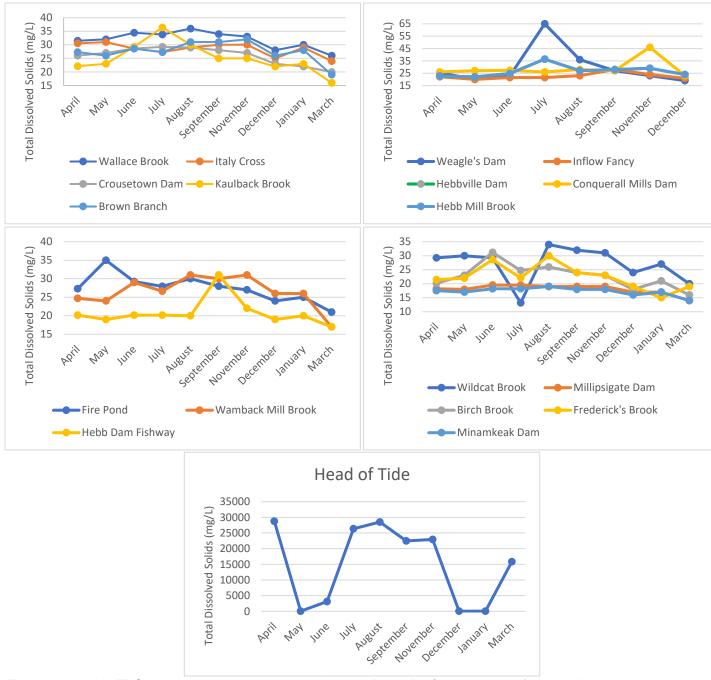
Figure 8. Monthly TDS measurements at 19 sites within the Petite Rivière watershed from April 2021 to March 2022.

Total dissolved solids (TDS) ranged from 13.2 to 26.7 mg/L across the 18 freshwater sites in the Petite Rivière in 2021 (Figure 8). At the Head of Tide estuarine site, it ranged from 24 mg/L to 28,756 mg/L, due to the influence of saltwater. Although the effects of TDS on fish are dependent on the life stage (Weber-Scannell and Duffy 2007), juvenile and mature Salmonidae can survive in waters with TDS greater than 2,000 mg/L. Based on the TDS measurements collected in 2021, the freshwater sites do not exceed this threshold, therefore, would not pose a threat to freshwater aquatic organisms.

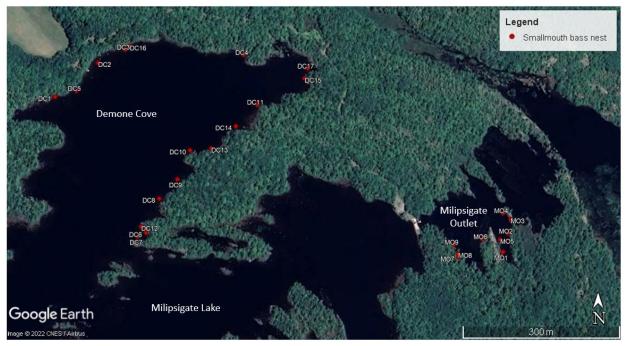
Figure 14. Locations of identified smallmouth bass nests in Milipsigate Outlet and Demone Cove in Milipsigate Lake between May 28 and June 8, 2021.

Demone Cove on Milipsigate Lake was surveyed over three days and Milipsigate Outlet over two days between May 28 and June 8, 2021 (Figure 14). During this time when the water temperature was between 17.7 and 22.8°C, 17 nests were identified in Demone Cove and 9 in Milipsigate Outlet (Figure 14). In Demone Cove, the majority of nests were classified as type A, newly excavated and without eggs, and the rest were either Class B or C. In Milipsigate Outlet the majority of nests were a tie between Classes B and C, two were a combination (partially hatched containing both eggs and fry; Figure 15), and the rest were either Class A or D. Each nest containing eggs or fry was destroyed, amounting to 11 nests, and a total of 23 males were angled from the nests. The substrate for all nests was pebble and cobble.

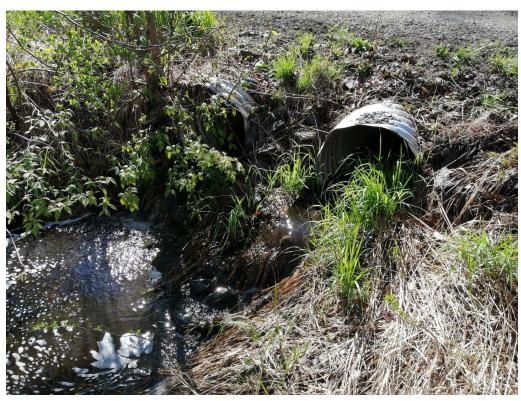
Figure 16. Double culvert: TOM002 on unnamed brook and Tompkin Road representing a full barrier to fish passage in both right and left culverts.

Culverts are significant barriers to fish and salmon passage, limiting their movement within watersheds and altering habitat (COSEWIC 2010A). Coastal Action staff conducted 22 crossing assessments; 14 of those crossings were bridges, and eight were culverts, although five of those culverts were not connected to fish habitats. Of these culverts, one was assessed as a partial barrier and two as full barriers. Table 7 presents culvert assessment results and opportunities for restoration. It is recommended that TOM 002 culvert be replaced; however, it is a low priority because there is limited upstream salmon habitat and would be complex to improve. At SHR001, a full crossing replacement is recommended, and it is of moderate priority because there is a significant amount of potential upstream habitat that would be made accessible if replaced. Lastly, SUK001 is a high priority barrier due to the significant upstream habitat and it is recommended that it be replaced or retrofitted if possible.

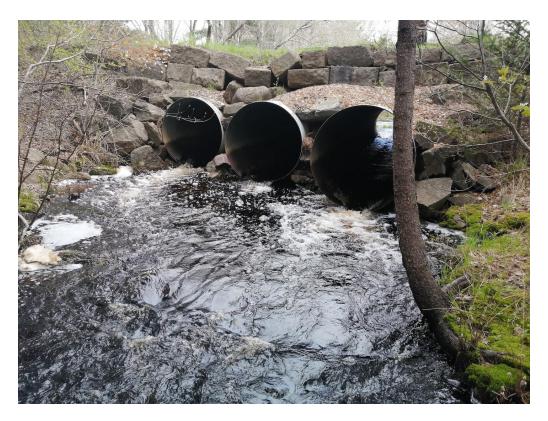
Figure 17. Triple culvert: SHR001 on Sheridan Brook and railway representing a full barrier to fish passage on the left culvert, and partial barriers to fish passage on the middle and right culverts.

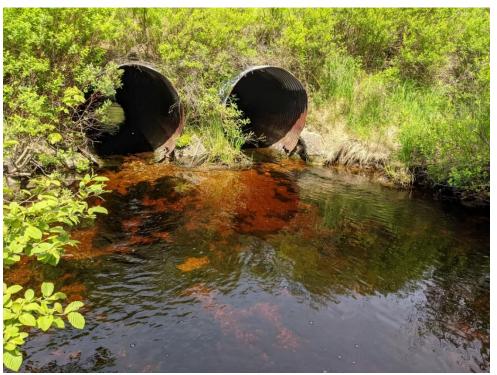
Figure 18. Double culvert: SUK001, on Suker Brook and Lake Pleasant Road representing a full barrier to fish passage in both right and left culverts.

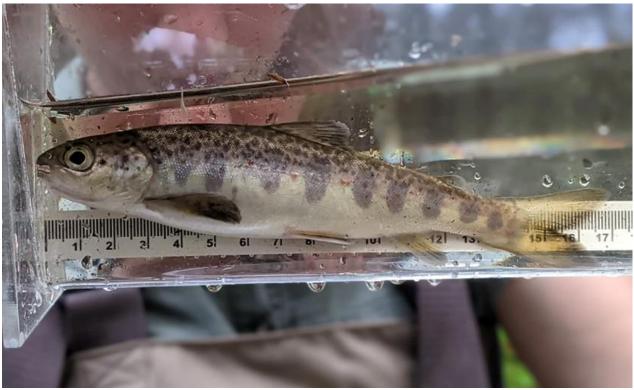
Figure 19. Atlantic salmon parr captured and measured in a clear fish viewer during electrofishing surveys at Zwicker Brook on August 25th, 2021.

Electrofishing was conducted on Zwicker Brook in the West Branch Sub-watershed and four different species were captured. During this survey, 11 Atlantic salmon parr were identified, indicating good quality potential nursery habitat at these sites (Table 8; Figure 19).
