2017-18 Project Summary Report:

Wildcat Brook Shale Pit Remediation & Wetland Expansion Project, Petite Rivière Watershed

March 2018

Bluenose Coastal Action Foundation
37 Tannery Road, Lunenburg, N.S., B0J 2C0

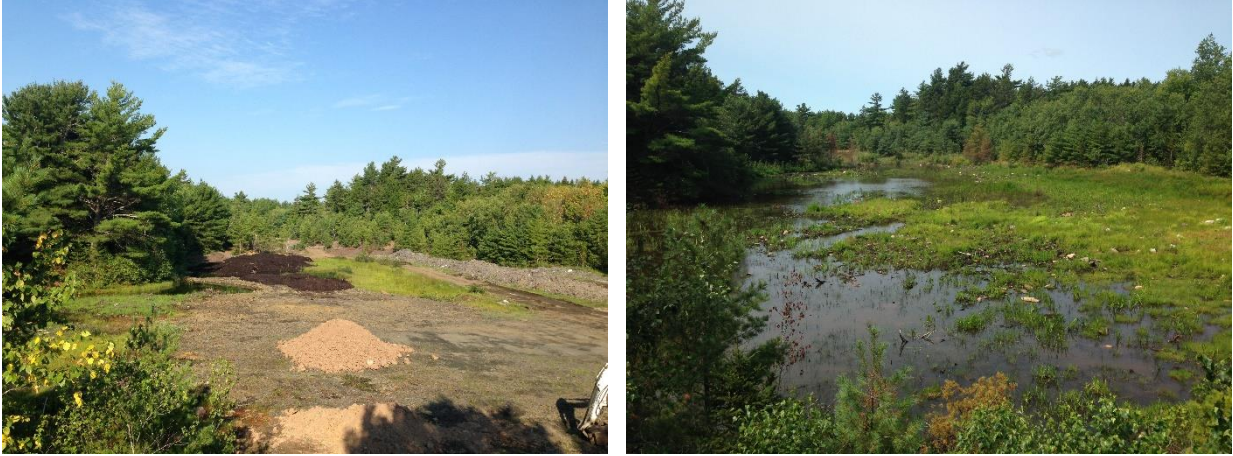
Figure 6. Photographs taken at the Eastern end of the Wildcat Restoration site. The **left** photograph taken August 2016, and **right** photograph taken August 2017.

The comparison of the 2016 photographs to 2017 photographs show an clear increased amount of vegetation density and the diversity. Additional point photos and baseline vegetation surveys can be found in Appendix E.

Vegetation point photos show a clear increase in amount of vegetation and the diversity from 2016 to 2017. Vegetation has continued to grow exponentially in the restoration site. More in-depth surveys are planned for the 2018 field season, which will involve density measurements and listing vegetation species. Results will then be compared to the baseline vegetation surveys taken prior to restoration work, and Coastal Action is confident there will be an increase in density and diversity of plant life.

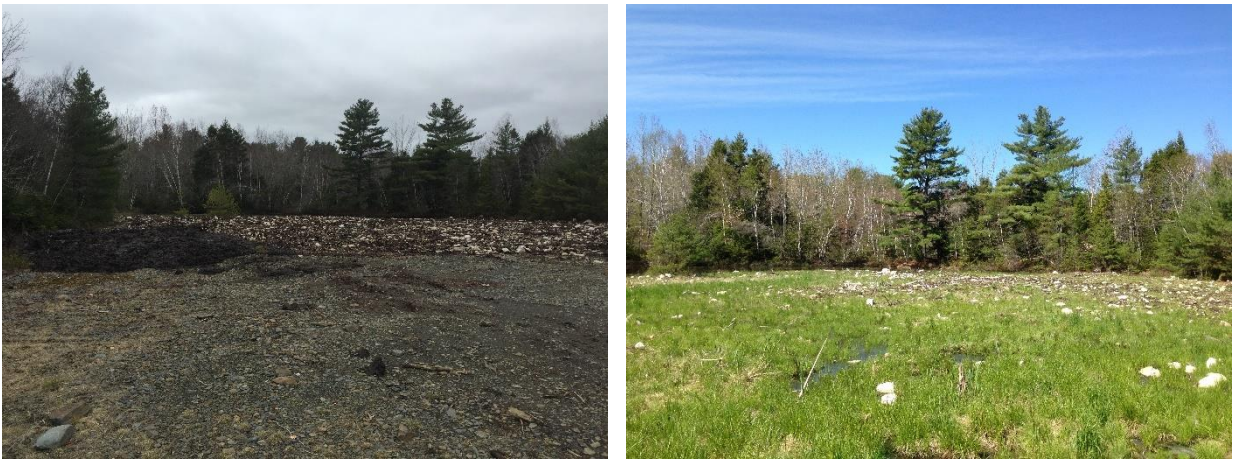
Figure 7. Photographs taken at the Western end of the Wildcat Restoration site. The **left** photograph taken May 2016, and the **right** photograph taken May 2017.

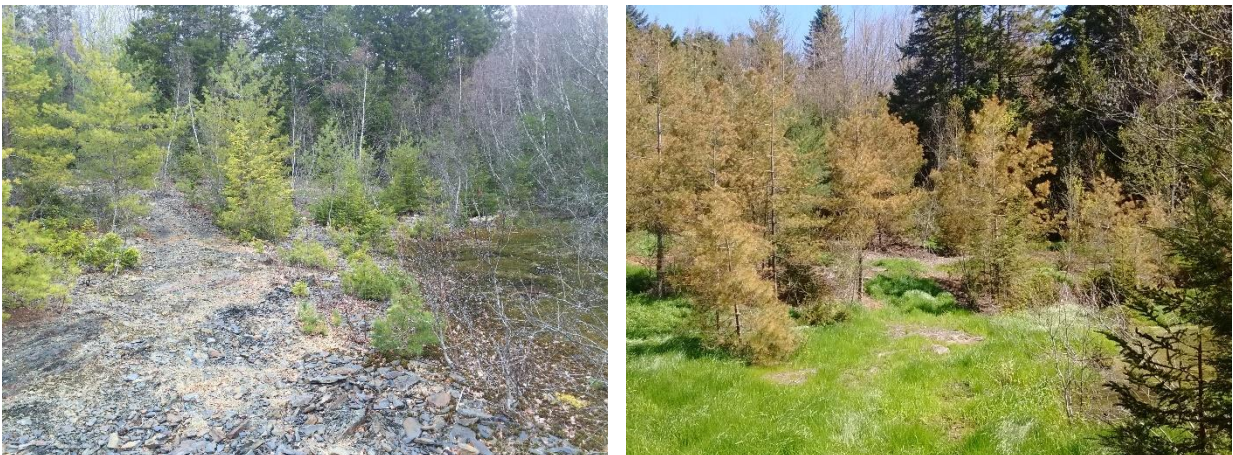
Figure 8. Photographs taken at the Northern end of the Wildcat Restoration site. The **left** photograph taken May 2016, and the **right** photograph taken May 2017.
