APRIL 2017

WILDCAT BROOK SHALE PIT
REMEDIATION & WETLAND EXPANSION
PROJECT, PETITE RIVIÈRE WATERSHED
2016-17 PROJECT SUMMARY REPORT

BLUENOSE COASTAL ACTION FOUNDATION
coastalaction.org

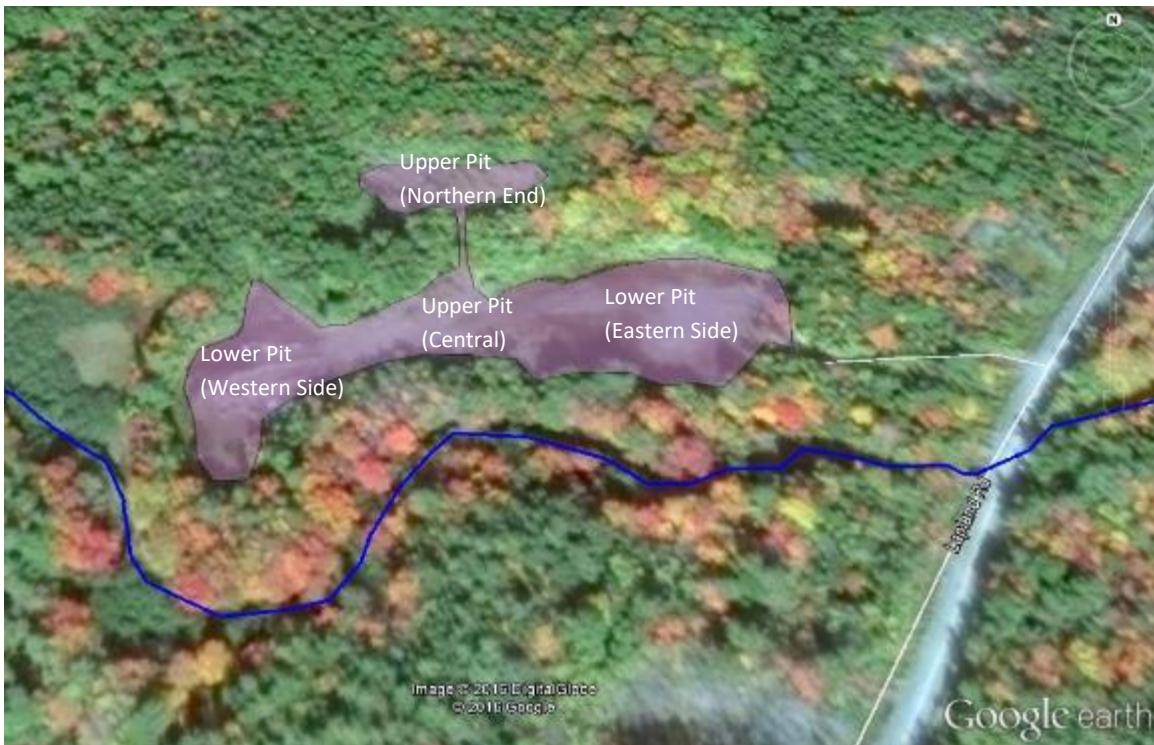
Figure 1: Aerial view of the Wildcat Shale Pit Remediation Site shaded in pink with adjacent Wildcat Brook depicted with blue line.

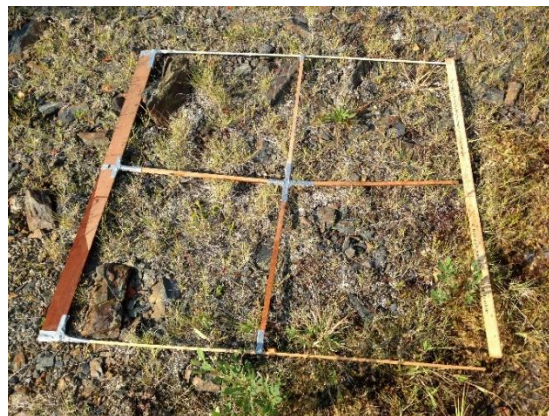
Figure 2: (Left) Conducting ground-truthing & wildlife survey with Reg Newell, NS DNR Wildlife Biologist. Figure 3: (Right) Vegetation density measurements taken with 1x1 square grid.

and density measurements of plant life using randomized 1 m² transects in four different sections of the shale pit.

Method: Remediation site was split into four sections (1-lower right, 2-upper right, 3-upper left, and 4-lower left) and each section sampled five times using a 1x1 square grid to measure randomized locations for presence of vegetation. * *These measurements do not account for large vegetation such as trees.*

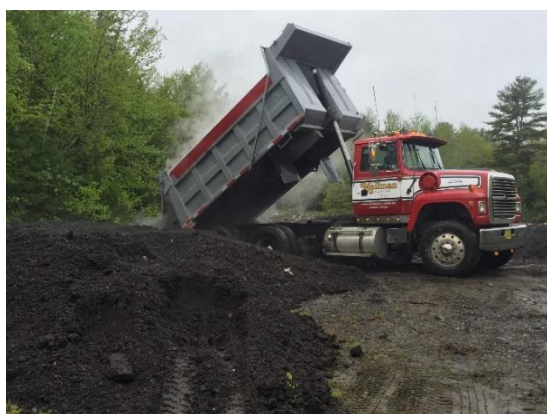
Figure 4: (Left) Dumping load of municipal compost. Figure 5: (Right) Constructing outlet weir in eastern side of restoration site.

Approximately 500 m³ of municipal compost material was used in the high-lying areas of the northern end and central areas of the pit (0.16 ha and 0.10 ha respectively). The nutrient-rich organic soil will encourage and support a healthy growth of vegetation in the high-lying areas of the restoration site, whereas the low-lying areas are nutrient depleted. The high-lying areas will support larger types of vegetation such as large trees and shrubs rather than the wetland grasses, sedges, reeds, and flowers found in the low-lying areas of the site. The areas covered with compost material were seeded with a native reclamation grass mixture and already have some young tree development.

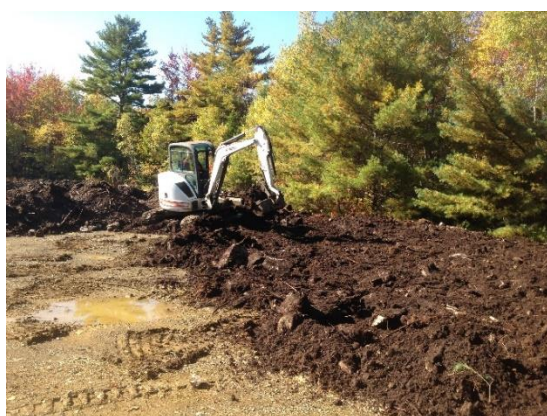
Figure 6: (Left) Spreading and landscaping with excavator in western side of Wildcat Shale Pit Remediation Site. Figure 7: (Right) Hand spreading of compost in northern end of Wildcat Shale Pit Remediation Site.

The low-lying areas, eastern and western sides of the remediation site, received 3,000 m³ of organic soil material, were flooded and planted with native wetland vegetation to encourage the formation of wetland habitat. The majority of the soil placed in the western side (0.35 ha) came from a development in Aspotogan, NS, which was approximately 80 km from the restoration site. The organic soil used in the eastern side of the restoration site (0.49 ha) came from Branch Tree Nursery, located only 2 km from the site.

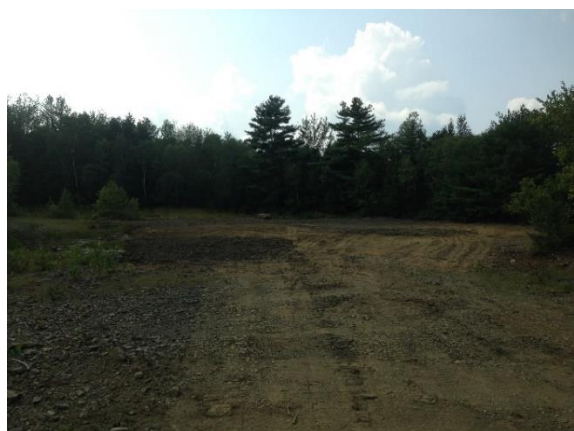
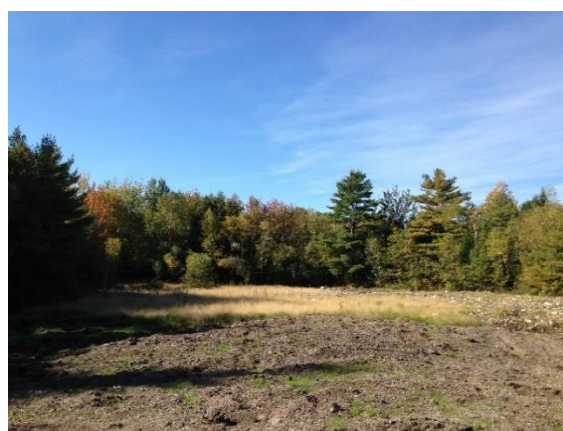
The restoration of the western side of the shale pit remediation site began in 2015 and was fully completed in early 2016. The below photos (Figures 8 & 9) show the western side of the site prior to and after the spreading of organic soils and the planting of wetland vegetation. The post-restoration photos were taken during a dry spell across Nova Scotia in 2016, which will account for some of the discolouration of the vegetation seen in below photos.

Figure 8: (Left) Pre-restoration, September 2015, of the western side (Lower Pit) of Wildcat Shale Pit Remediation & Wetland Expansion Project. Figure 9: (Right) Post-restoration, October 2016., of the western side.

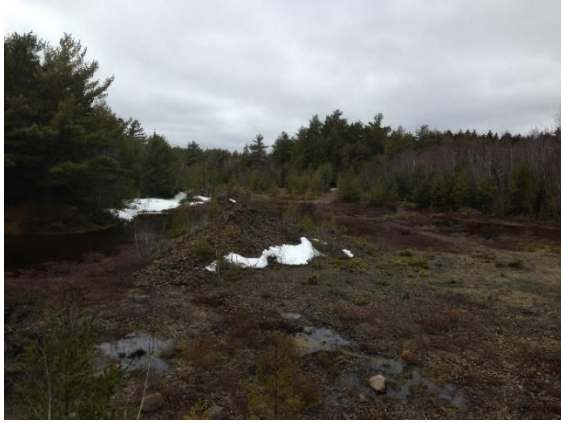
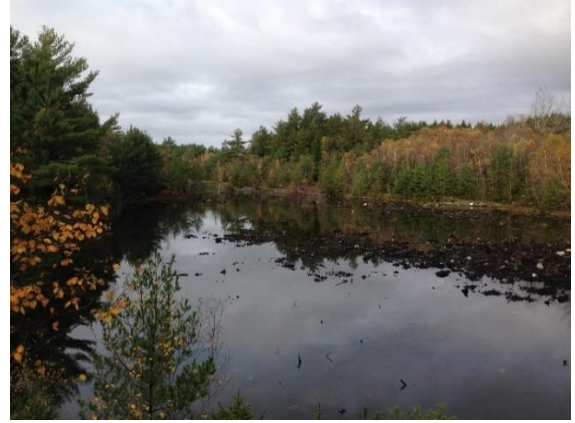
Restoration of the eastern side of the shale pit remediation site began in the spring of 2016 and was fully completed Fall 2016. The below photos (Figures 10 & 11) show the eastern side of the remediation site prior to and after the spreading of organic soils and the planting of wetland vegetation.

Figure 10: (Left) Pre-restoration, April 2015, of the eastern side (Lower Pit) of Wildcat Shale Pit Remediation & Wetland Expansion Project. Figure 11: (Right) Post-restoration, October 2016, of the eastern side.

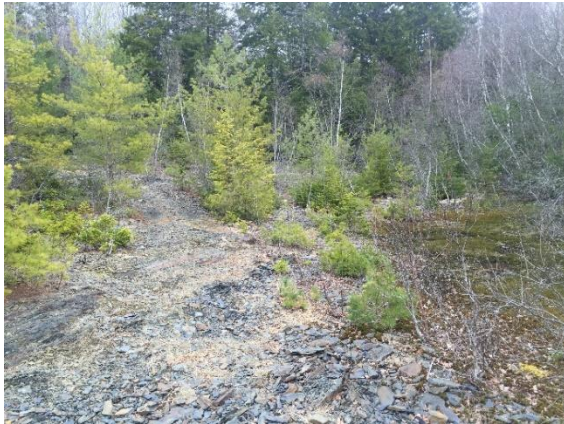
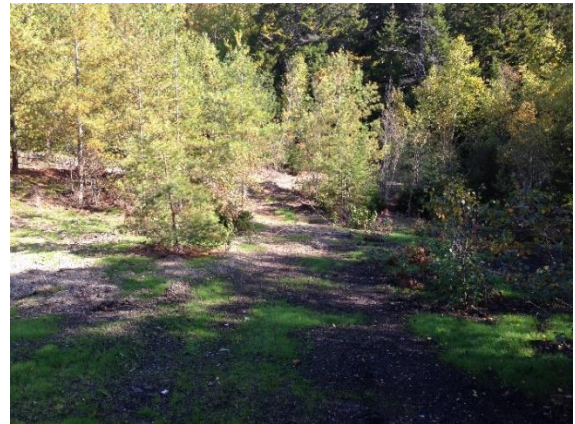
Restoration of the northern end and central pit area began in the spring of 2016 and was fully completed Fall 2016. Below photos (Figures 12 & 13) show the northern end of the remediation site prior to and after the spreading of municipal compost over the exposed shale bedrock and the seeding of soil. The beginning of new vegetation growth is visible and will continue to grow and fill in over time.

Figure 12: (Left) Pre-restoration, May 2016, of the north end (Upper Pit) of Wildcat Shale Pit Remediation & Wetland Expansion Project. Figure 13: Post-restoration, October 2016, of the north end.
