**Petite Rivière  
Fish Habitat  
Restoration Plan  
2014**

Habitat Stewardship Program for Species at Risk

This is the first of annual reports as part of the development of the Petite Rivière Fish Habitat Restoration Plan. This document provides a background of the living biology, chemistry, and physical geology of the Petite Rivière watershed, as well as provides the beginnings of a habitat description and restoration opportunities for the watershed. The sub-watershed of Wildcat Brook (approximately 9 km watercourse) has been the first and only sub-watershed that has under-gone stream assessments and restoration during the 2014-15 field season. The Wildcat Brook system is situated in the upper right section of the Petite Rivière watershed. Future reports will investigate additional sub-watershed assessments and outline potential restoration opportunities.

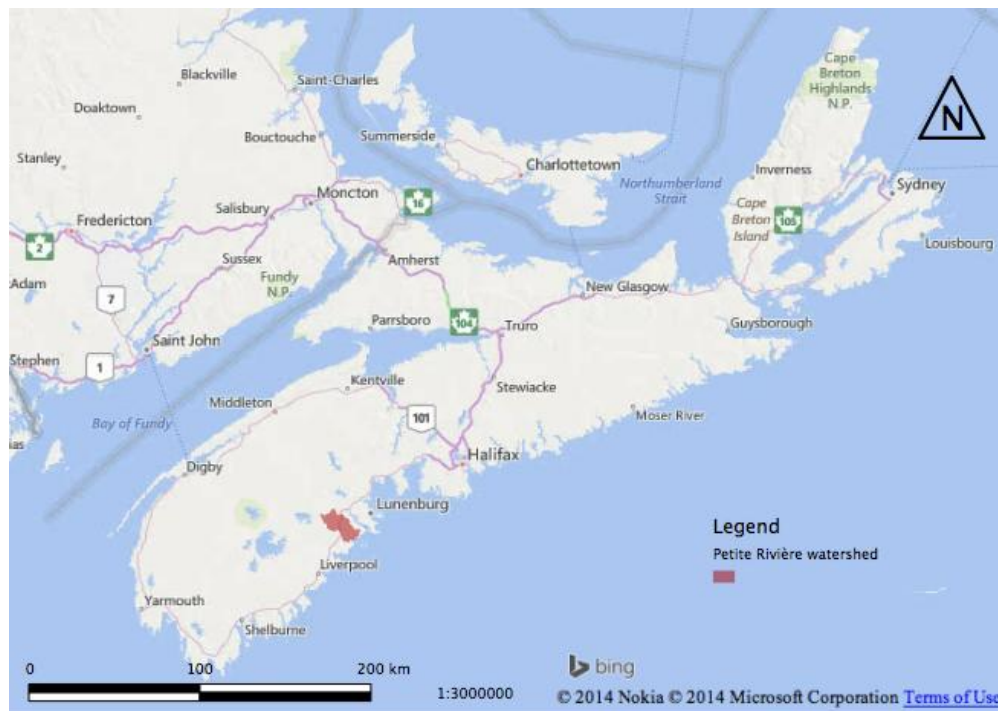
**Figure 1:** Petite Rivière watershed boundary (red) located in Nova Scotia.

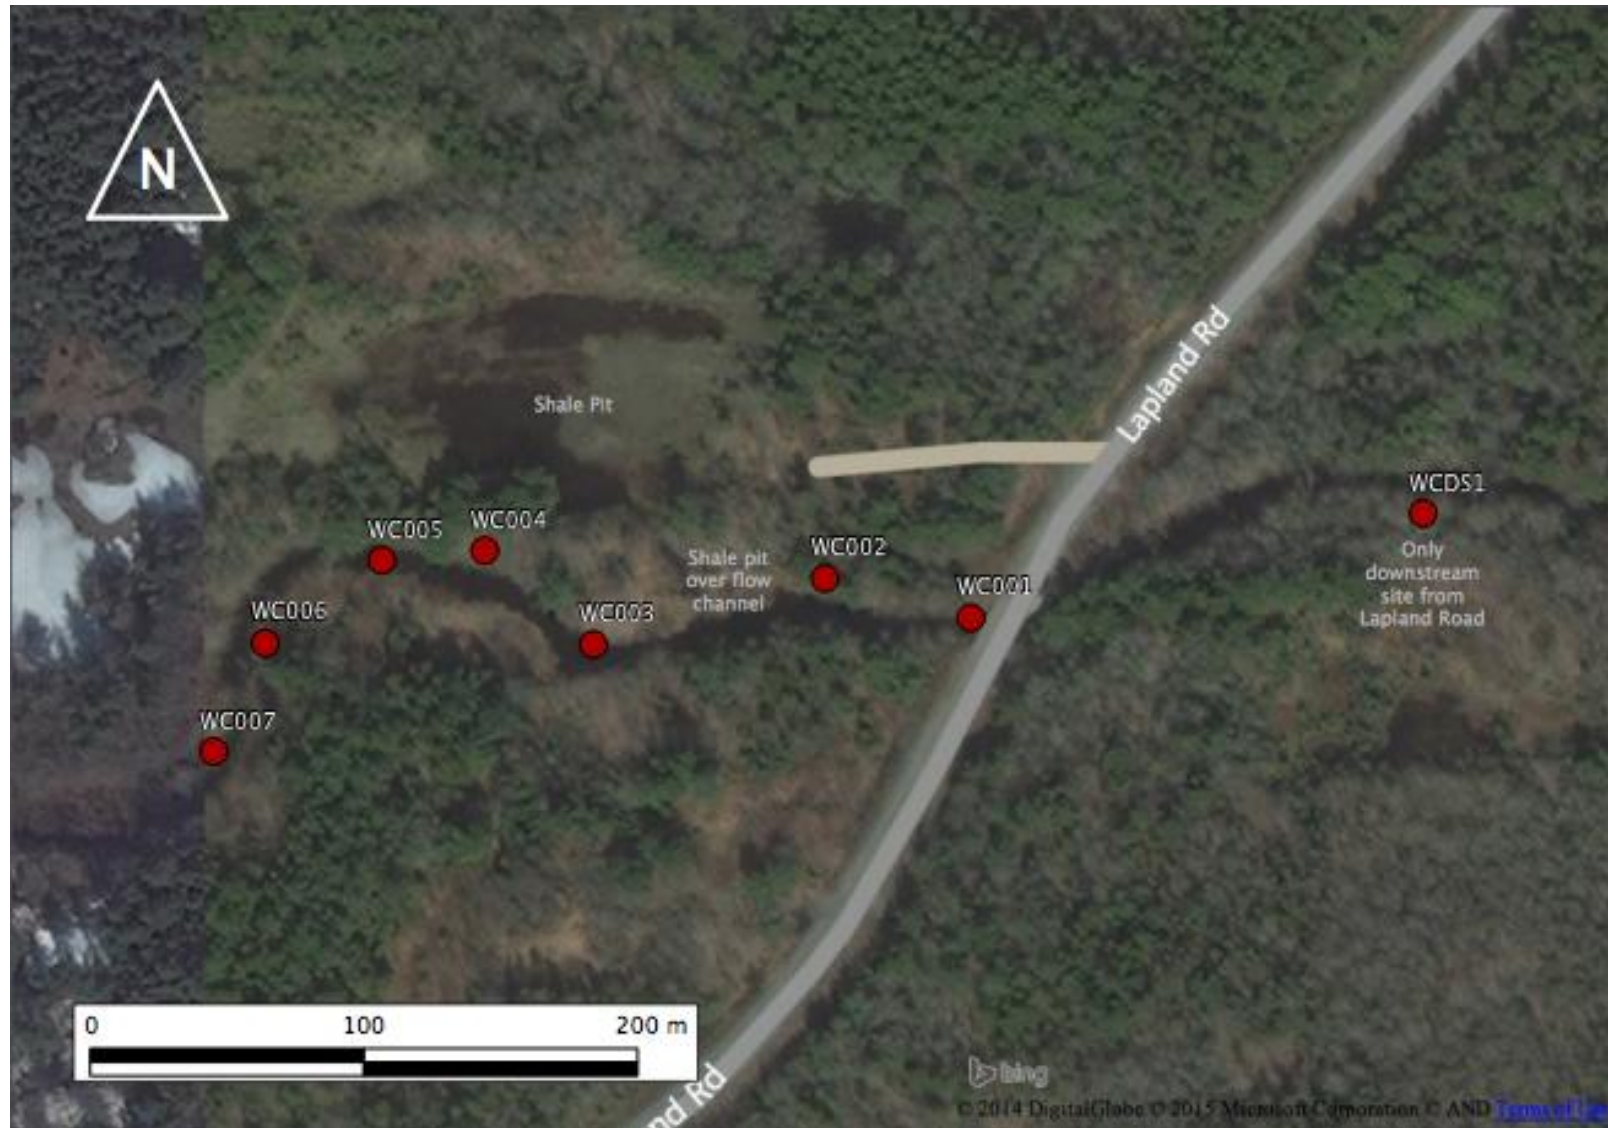
**Figure 3:** Locations of site assessments on Wildcat Brook. Red markers show sites WCDS1, downstream from Lapland Rd. and sites upstream from Lapland Rd. WC001 to WC007 (scale 1:2000).

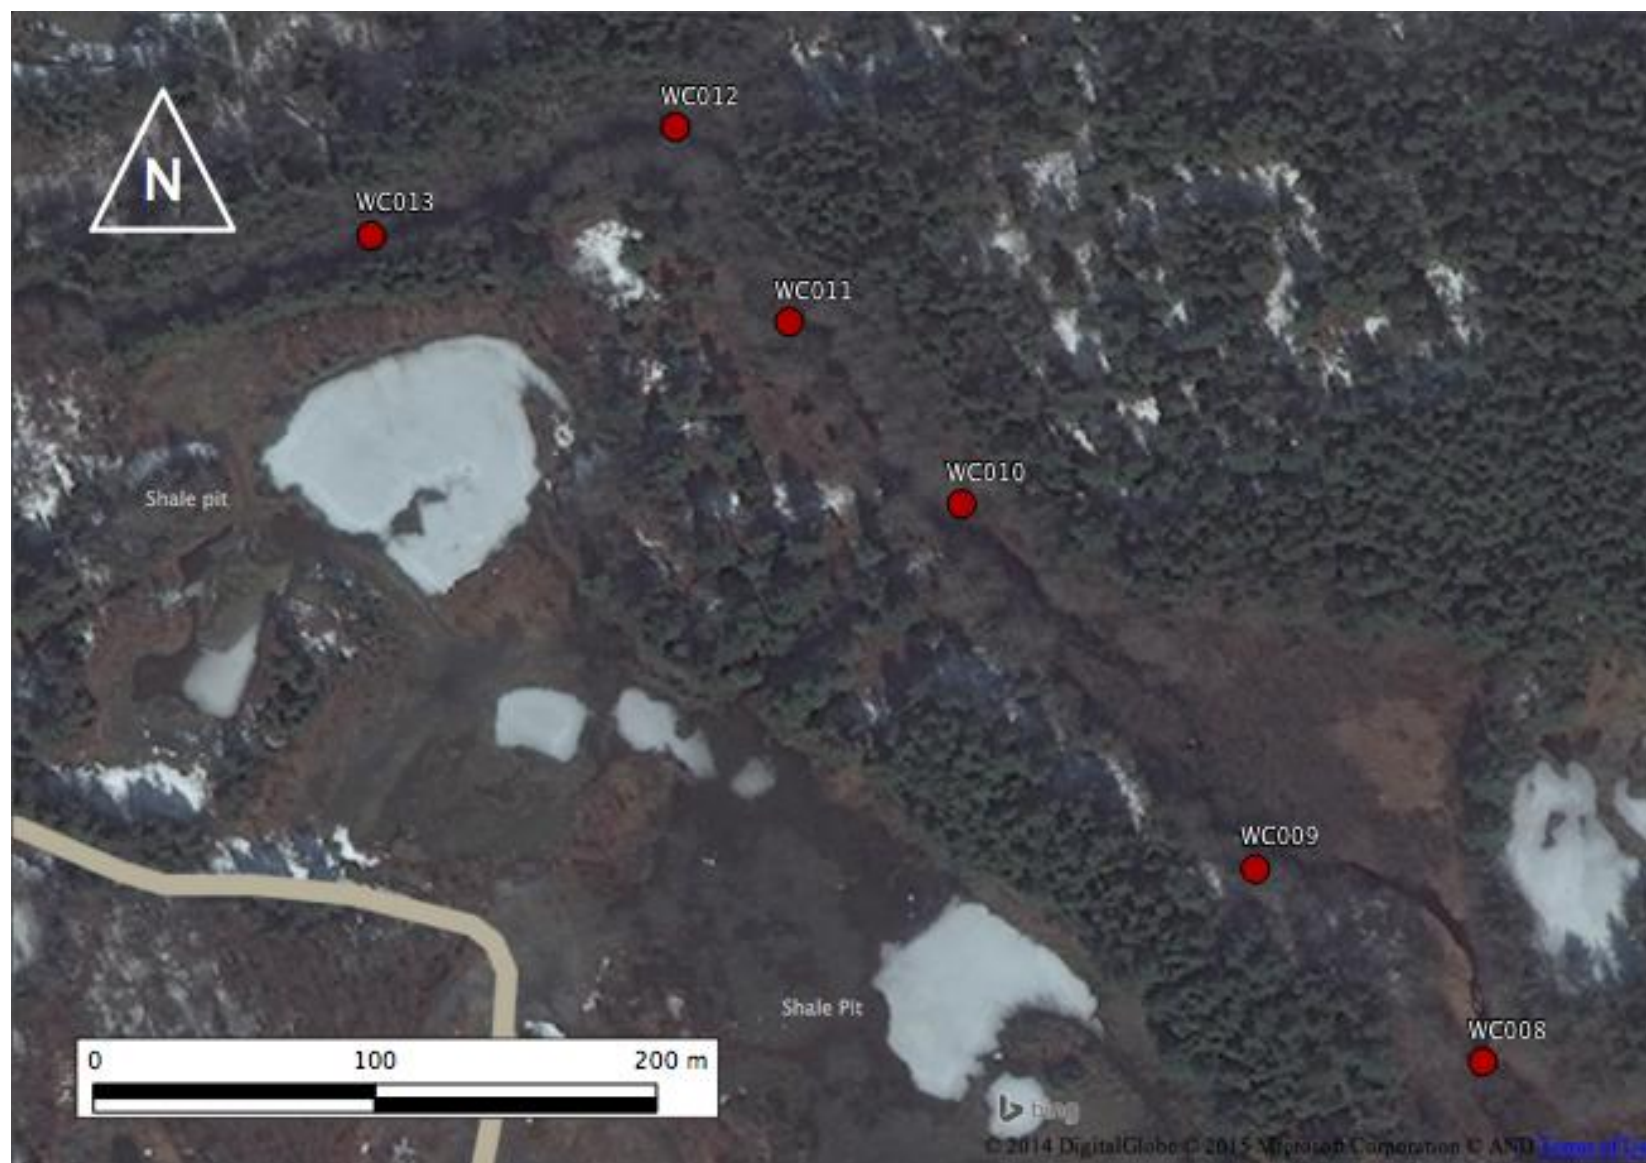
**Figure 4:** Location of site assessments on Wildcat Brook. Red markers show sites WC008 to WC013 (scale 1:2000).

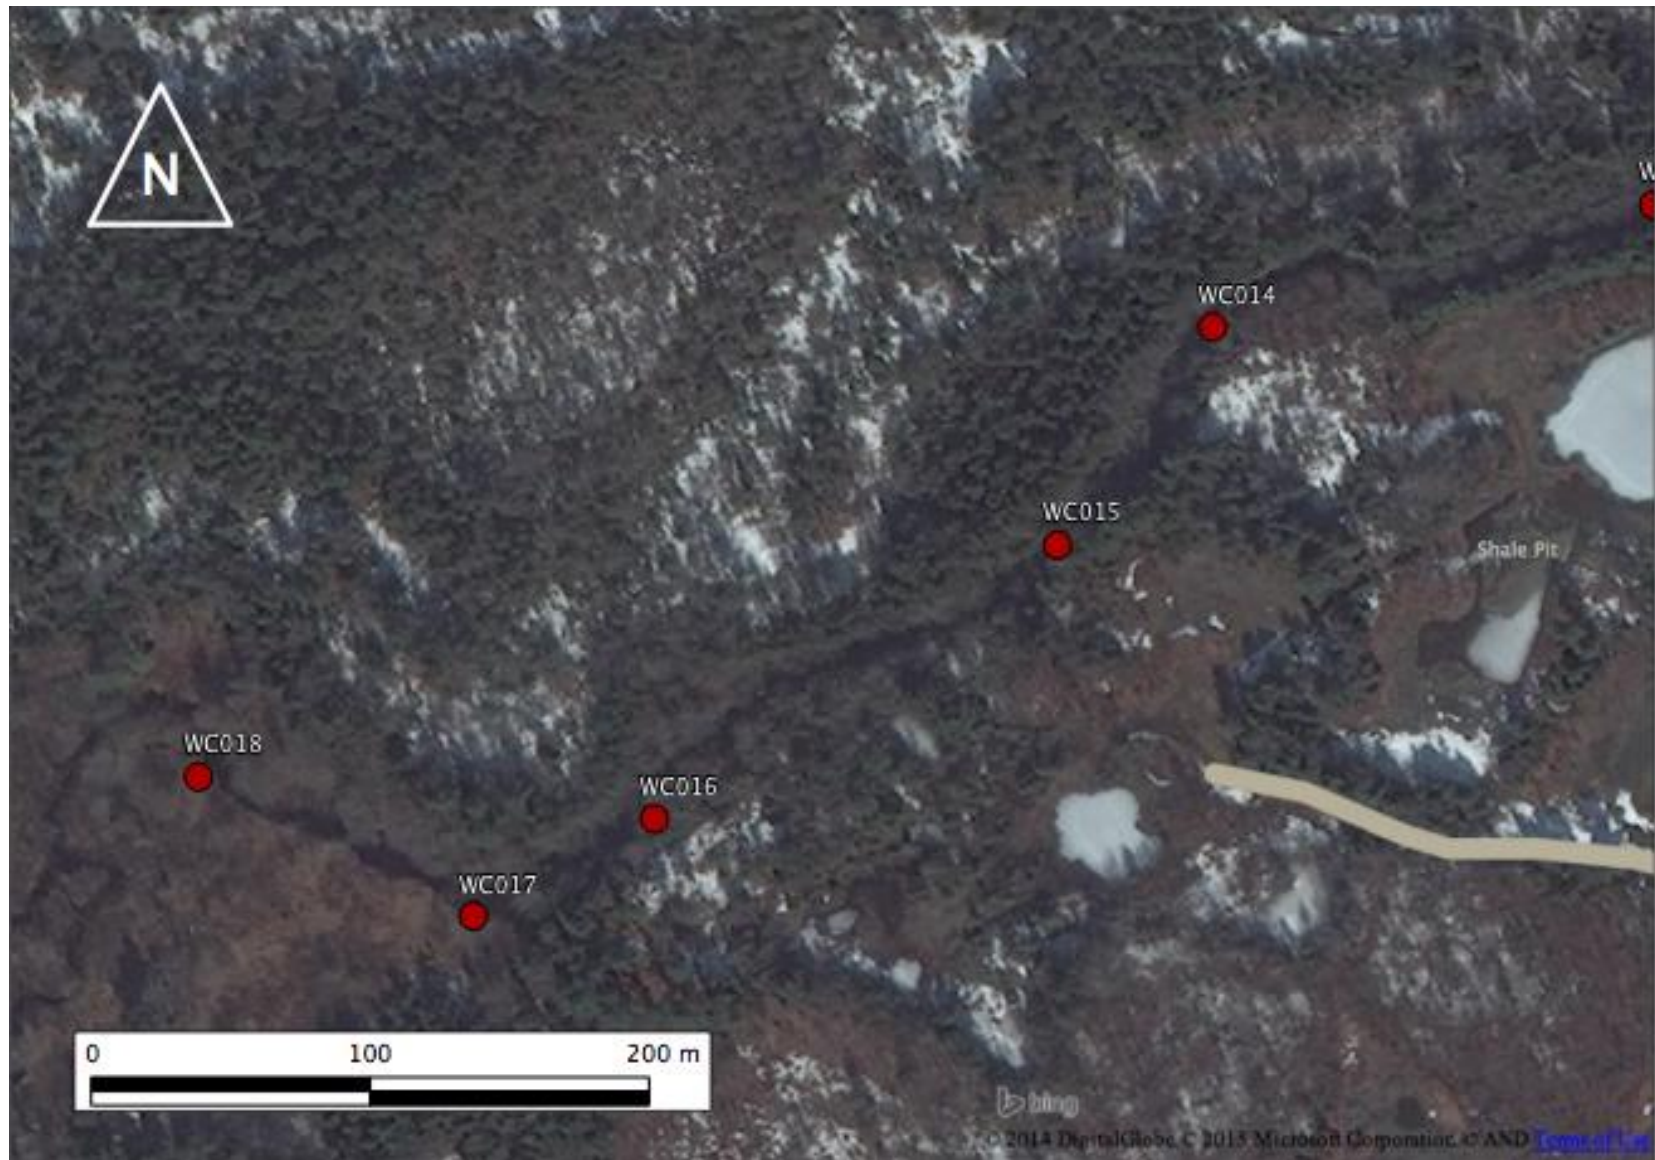
**Figure 5:** Location of site assessments on Wildcat Brook. Red markers show sites WC014 to WC018 (scale 1:2000).

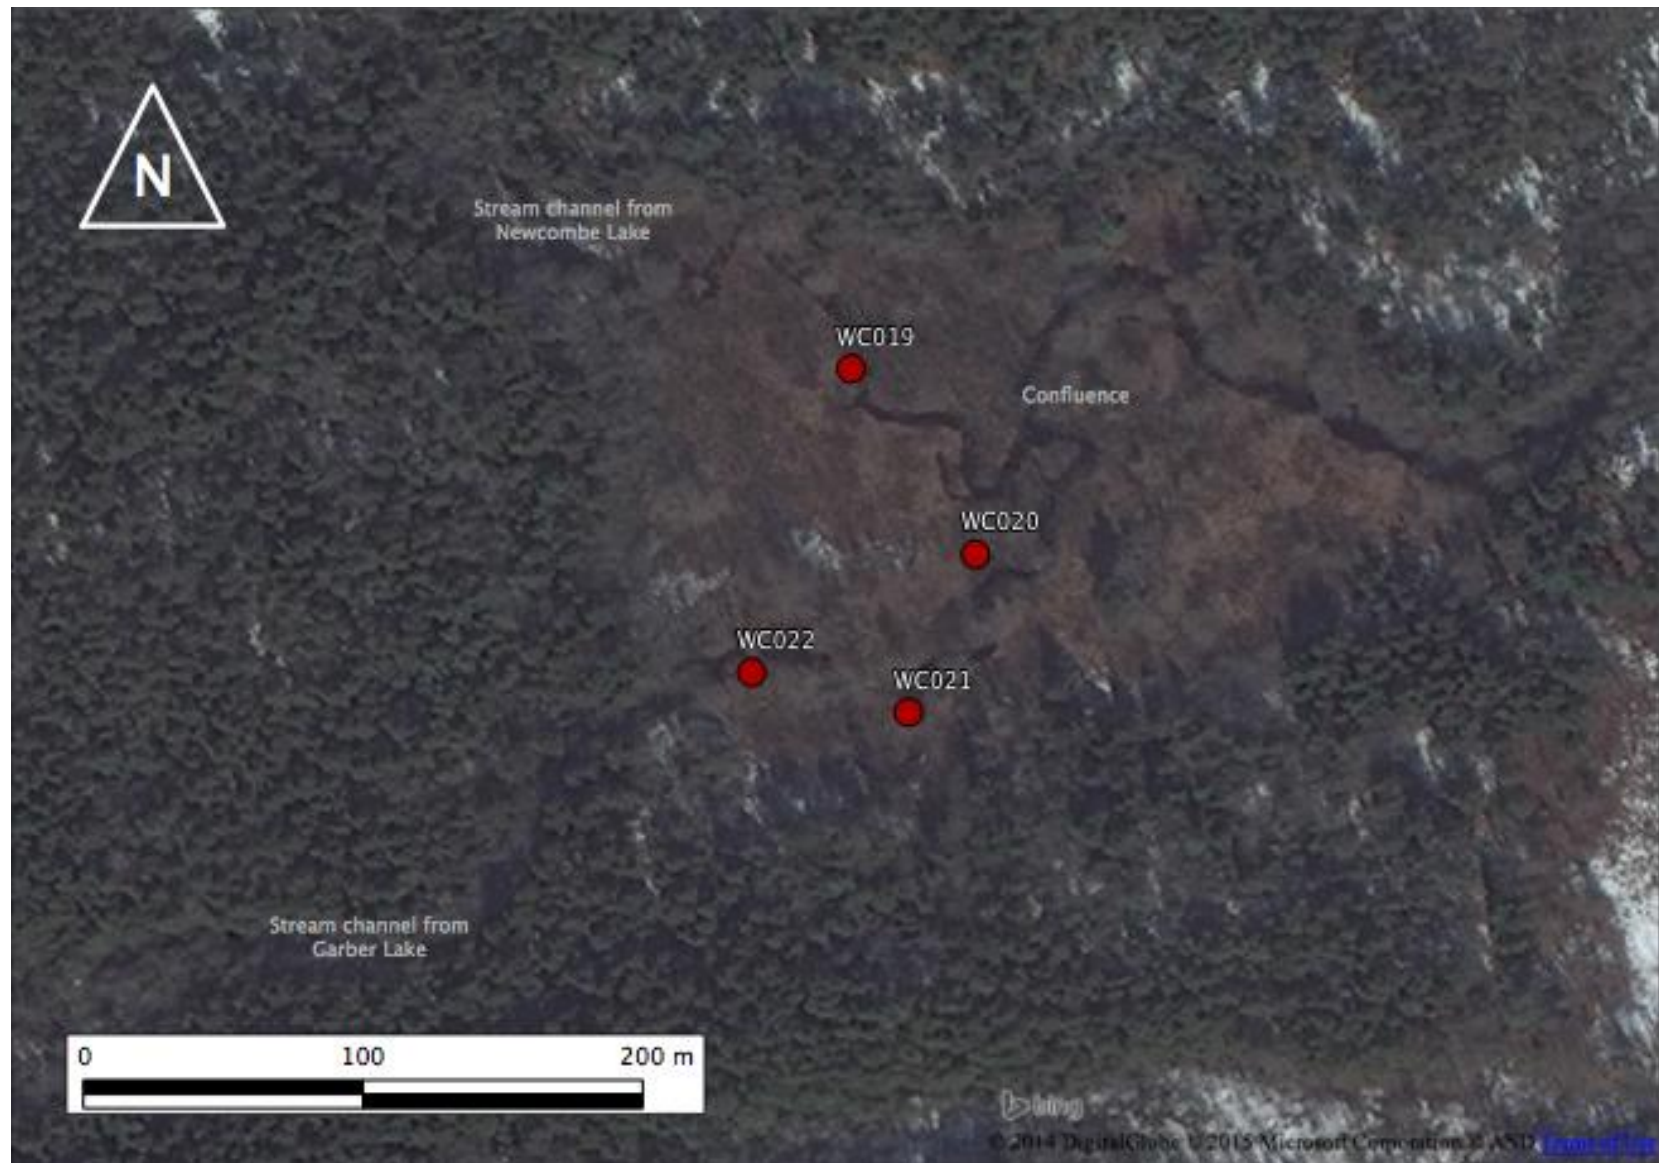
**Figure 6:** Location of site assessments on Wildcat Brook. Red markers show sites WC019 to WC022 (scale 1:2000).

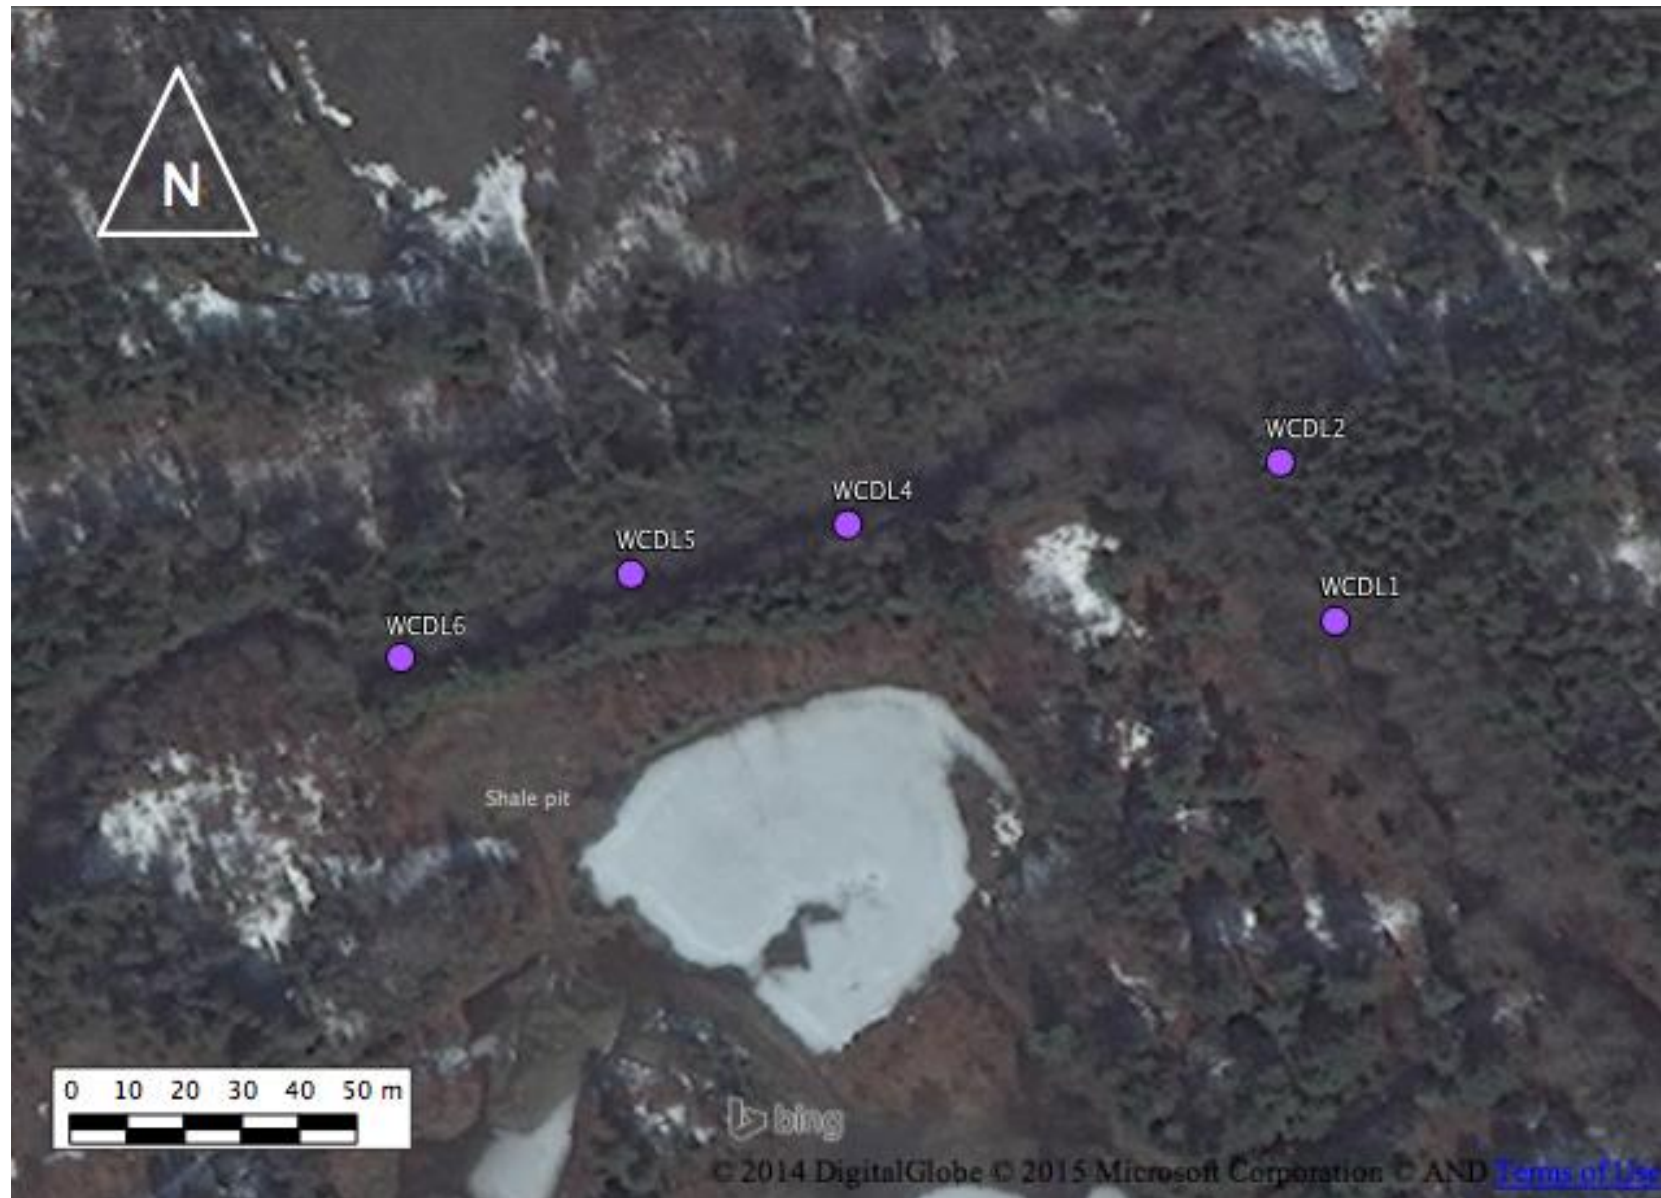
**Figure 7:** Purple markers show the location of the installed (WCDL2 to WCDL6) digger logs and deflectors. WCDL1 has yet to be installed in proposed location.
